# Acceleration measurements on tile-press bearings

by Heinz Joas

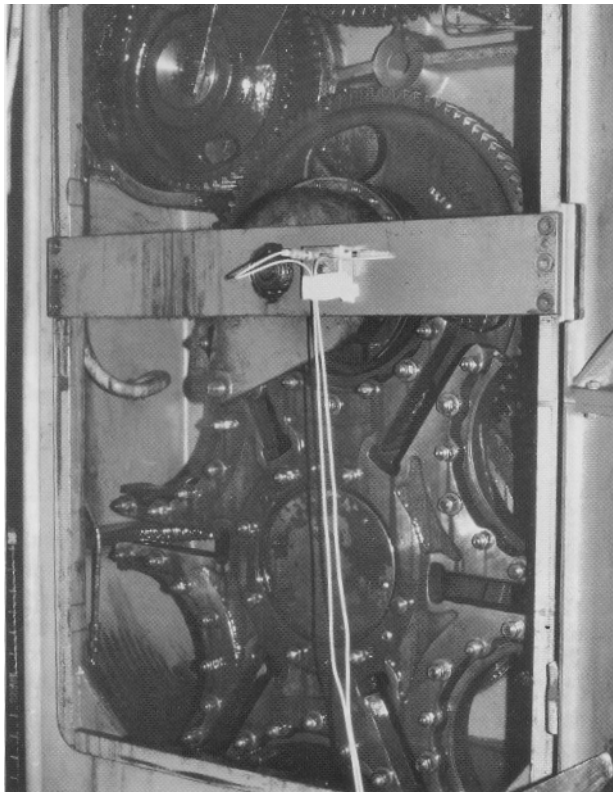
**Fig. 1: A pair of B 12 Acceleration Transducers**

The cause of the problem was traced by using inductive acceleration and displacement transducers which were fitted both to a perfectly operating press and to the new press at identical measuring points, but in particular near to force transfer points such as bearings. **Figure 1** illustrates the pairs of B 12 Acceleration Transducers that were mounted on the bearing of the crosswheel drive. **Figure 2** shows the positions of the measuring points on the press.

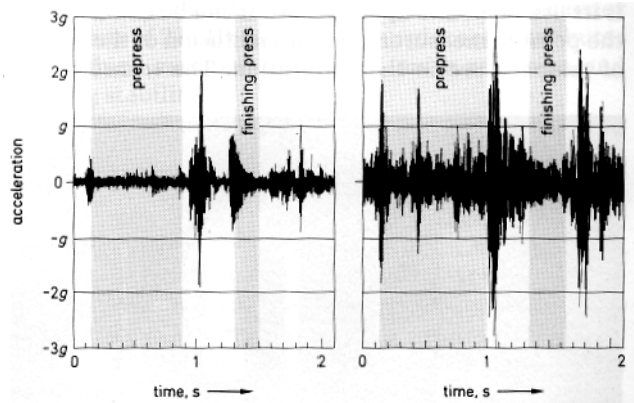
Since the old and new machines were operated in parallel, the results could be compared immediately. **Figure 3** shows the amplitude occurring during an operating cycle and **Fig. 4** a frequency analysis of two signals recorded at comparative points in operation. The greater amplitude of acceleration occurring at higher frequencies can be seen on the faulty machine.

**Fig. 3: Acceleration amplitude on the non-faulty bearing (left) and the bearing showing signs of wear (right)**

Recurring vibration measurements including analysis are to be used in the future to provide information on bearing damage.

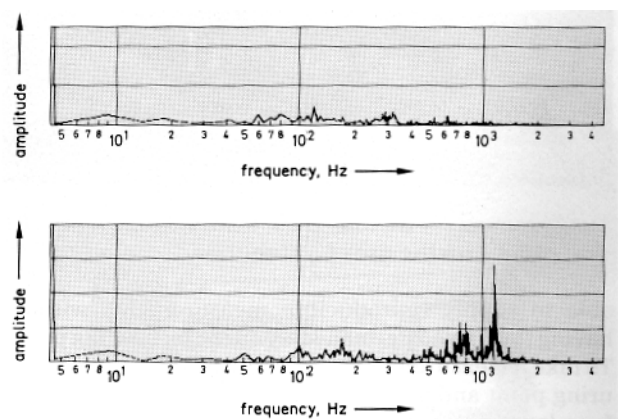
**Fig. 4: Frequency analysis on the non-faulty bearing (top) and on the worn bearing (bottom)**
