Reduction of oscillations on a passenger boat

by Heinz Joas

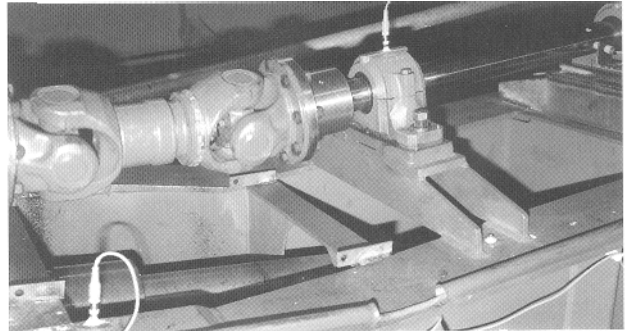
Oscillation measurements were carried out at various speeds to obtain information on the constructional changes necessary to produce an improvement. A total of four B 12 Acceleration Transducers were installed on the main deck, on the gear box and on the shaft bearings on both the motor and transmission sides. **Figure 2** illustrates two of these measuring points. The transducer signals were amplified by the KWS 28 5 kHz CF Measuring Amplifier shown in **Fig. 3** and then passed to a line recorder and a magnetic tape recorder. The resonant frequencies of various component parts were also determined by impulse excitation.

Fig. 2: B 12 Acceleration Transducer on the shaft bearing and the bed of the gearbox

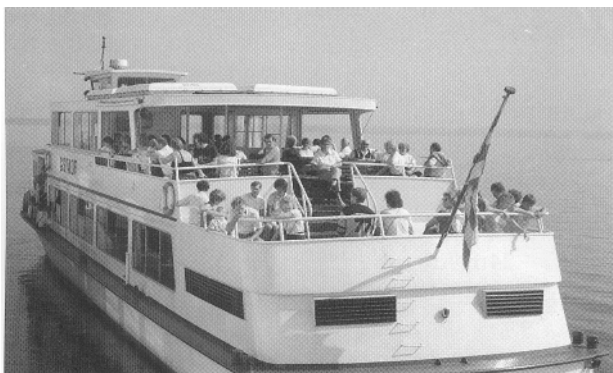
During the commissioning of the new passenger boat shown in **Fig. 1**, oscillations occurred at higher speeds which were particularly irritating in the region of the main passenger decks. Further damping of the motor mountings and coupling and the fitting of additional bearings for the propeller shaft did not significantly improve the situation.

Fig. 1: The passenger boat on which tests were made

A reduction in the oscillations was obtained with a relatively simple stiffening in the ship's ribs, which raised the resonant frequency beyond the maximum operating frequency. This reduced the irritating deck oscillations to an acceptable level. If required, further

remedies could be implemented, i.e. changing the motor speed, modifying the gear transmission or changing the number of blades on the propeller.

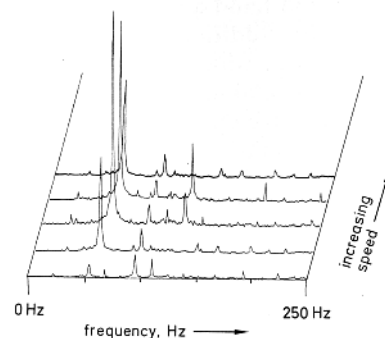
A visual evaluation of the acceleration signals was made and to compare the recorded analog trace, a computerized frequency analysis of the tape recordings produced cascade diagrams for various motor speeds as shown in **Fig. 4**. The evaluation showed that with rising speed the amplitude of the oscillations reached a maximum and then reduced with a further increase in speed. The reason for this is that in the speed region of 1600 rpm the 64 Hz resonant frequency of the ship's structure and the two second order excitation frequencies from the motor shaft (66.4 Hz) and from the four-blade propeller (56.5 Hz) are very close together. A further reason for the unpleasant sensation is the resonant frequency of the globe of the human eye between 40 Hz and 80 Hz.

Fig. 4: Amplitude spectrum for increasing speed
