Monitoring the settling of the river pier supporting the Inn valley expressway bridge at Kufstein, Austria

by Martin Aschaber

Erosion of the bed of the River Inn at Kufstein led to the sudden settling of an expressway bridge. The bridge was part of an important international communications link and its prompt repair was eagerly awaited. One problem for the engineers involved in the repair work was the monitoring of the settling of the bridge. The author describes the measuring method used which comprised a differential level monitoring system based on interconnected water vessels.

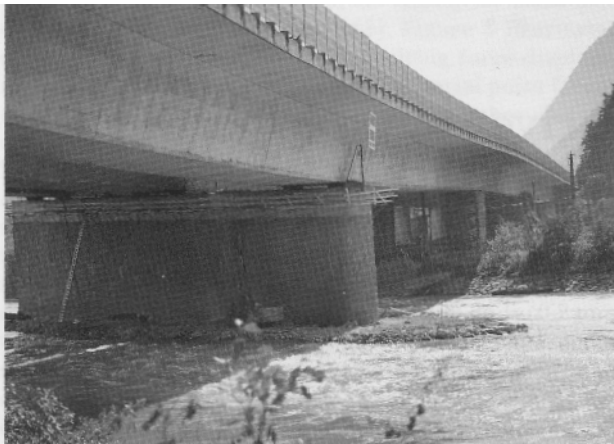
In the early hours of the next day it was found that the damage had been caused by the settling of the river pier. The pier had sunk about 1 m (3.2 ft) on the downstream side. This value increased during the day to about 1.15 m (3.77 ft). On the upstream side the amount of settling was approximately 22 cm (9 in). The pier had also tilted towards the righthand river span; the degree of tilt was about 60 cm (2 ft) over the pier

Fig. 2: View of the bridge and river pier from the downstream side after initial safety work had been carried out

height of about 16 m (52.5 ft). In addition, the unreinforced pier shaft had a vertical crack about a third of the way along from the upstream end. **Figure 2** shows a view of the bridge and river pier from the downstream side after the initial preventative measures had been taken.

- filling with stones to stabilize the river pier after carefully considering the safety aspects of working under the bridge. In total, about 40,000 t (39370 tons) of stones were placed around the pier;
- setting up of auxiliary supports at Pier C;
- removal from the river area of the remainder of the auxiliary framework which had been erected for previous repair work to the highway bridge.

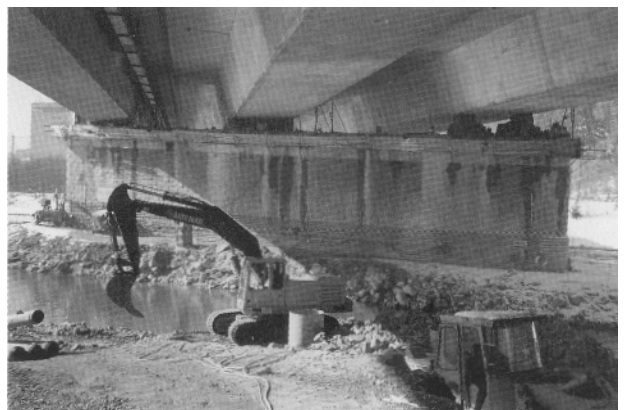
Fig. 3: View of the river pier from the right-hand bank after lifting the girders, showing the temporary prefabricated bearing stacks

As the subsoil injections progressed, the girder supporting the interstate highway was lifted with hydraulic jacks into its original position and temporarily supported on bearings on the river pier. Soon, on the 31st August 1990, the interstate highway bridge could be brought into operation for the expressway traffic. Both of the expressway girders were then lifted. Here, special safety measures were needed due to the horizontal girder displacement of about 20 cm (7.9 in) at the pier. The girders were tensed like springs. This tension had to be slowly brought under control using hydraulic jacks. The expressway girders are now still lying on temporary bearings on the river pier. The space between the nose of the settled pier and the girder which had been raised to its original position is filled with prefabricated bearing stacks. This situation is shown in Fig. 3 which also illustrates the river pier with raised girders and intermediate bearing stacks as viewed from the right bank. The final positioning will be made on the concreted pier. The work required for this will be carried out while maintaining traffic flow. Since it is not possible to bring the river pier to an upright position, the complete pier will be "jacketed" with a surrounding reinforced concrete apron.

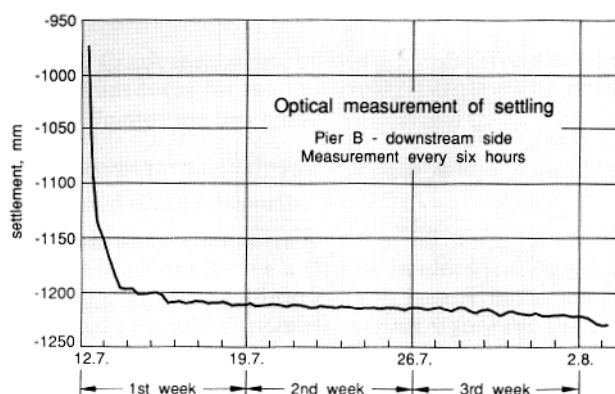
Immediately following the occurrence of damage an observation post was set up that same night and the progress of the pier settlement was measured using optical means. Figure 5 shows the variation with time of the measurements obtained on the downstream side of the river pier. What was needed for monitoring the pier settlement was an electronic method that automatically acquired the measurements and transmitted them to the measurement station, enabling logging of the results and inclusion of the settlement measurements in the alarm system. It was decided to use an electronic water level system which had already proved useful in settlement measurements.

Fig. 5: Results of the optical measurements taken on the river pier which began immediately after damage occurred

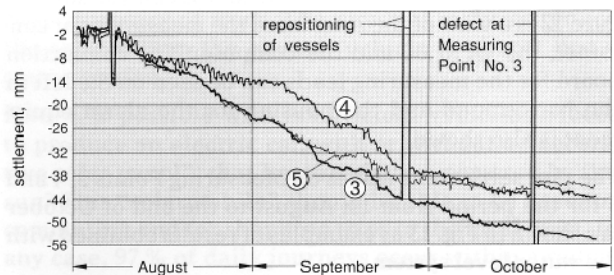
Fig. 13: Results of settling measurements at Measuring Points 3, 4 and 5 in the water level system from the beginning of August to the end of October 1990

The pier settlement values on Measuring Points 3, 4 and 5 for the period from 1st August to the end of October are shown in **Fig. 13** as examples of results obtained with the water level system.

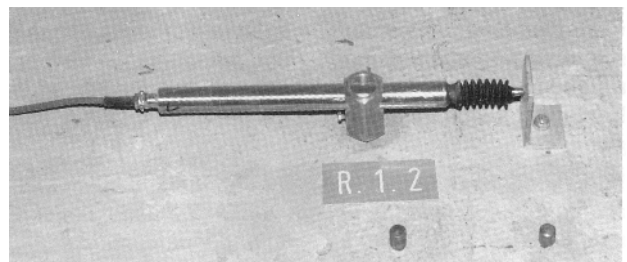
Fig. 14: Crack measuring point with inductive displacement transducer for monitoring the width of the crack on the floor of the box girder

Inductive displacement transducers of the type W 20 TS were installed to monitor the behavior of cracks in the structure at selected points. The transducers were arranged to measure the width of the cracks and **Fig. 14** illustrates a crack measuring point on the floor of the box girder.

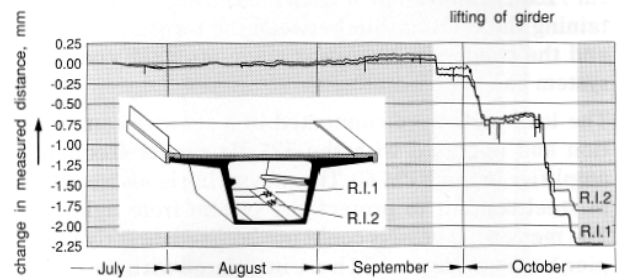
Figures 17 and 18 show the results measured with the inductive displacement transducers. **Figure 17**, which also illustrates the position of the measuring points on the floor of the bridge box girder, clearly shows the closing of the crack which accompanied the girder lifting process. This trend can also be recognised from the results of the two wire extensometers shown in **Fig. 18**.

Fig. 17: Measurement results at two crack measuring points using inductive displacement transducers on the floor of the box girder

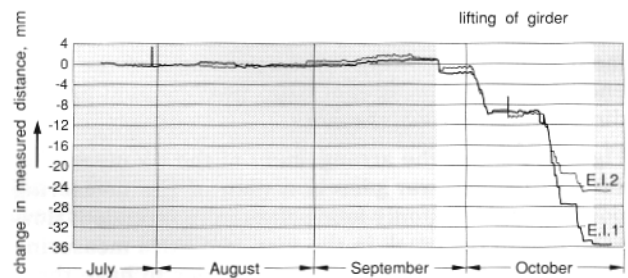
Fig. 18: Changes in length measured with the wire extensometers shown in **Fig. 15**
