## Measurement verification of the stress reduction on a water vessel by shape modification of a welded part

by Heinz Joas

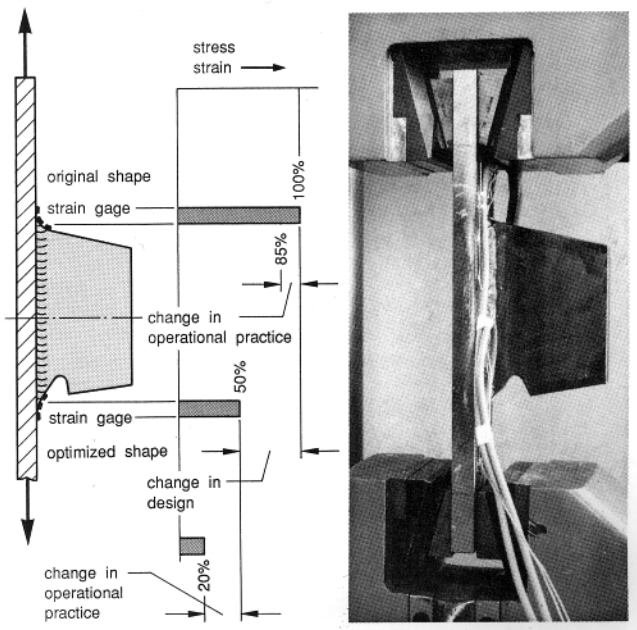
**Fig. 1: Shape optimization on the transition region between the welded bracket and the tank wall;**

Shortly before finalizing inspection, a problem was found on the internal wall of a feed water tank at a power station. Cracks with a maximum depth of 4 mm (0.16 in) were found in welded mounting brackets after a three-year operating period. The tank is 50 m (164 ft) long with a diameter of 4 m (13 ft). All the cracks on the welded parts were ground away and the brackets non-destructively tested again. Metallographic examination showed that the cause of failure was strain-induced crack corrosion. This could be traced to cracks arising in the magnetite coating applied as corrosion protection to the area in question. The cracks were formed on the inside of the tank wall.

The welded brackets acted as local clamps preventing deformation in the container wall which is relatively thin and easily elastically deformable. This in turn leads to stress concentrations in the joint regions. These increased stresses exceed the local strain capabilities of the magnetite coating and induce cracks in it. At the points of these cracks corrosion then causes deeper cracks in the tank wall. With regard to other power station units, it was important to be able to assess the degree to which the stresses arising from the design and from the mechanical and thermal operational loads were significant factors causing the damage. Therefore, strain measurements with strain gages, together with temperature measurements, were carried out at critical points over a few months of operation.

**left: original and optimized shape of the transition part and strain-gage measuring points**

**center: diagram showing the reduction in stress due to the modified shape and the change in operational practice**  
**right: comparison of the stress concentrations in the differently shaped transition regions by strain-gage measurement in a tensile test in a testing machine.**

Since the design of the brackets in the regions where they joined the tank wall already pointed to the formation of significant stress concentration at this point, this part was immediately geometrically optimized on a prototype basis. In the cross-sectional transition, which was the most susceptible part, larger radii were ground into the brackets. The success of this modification in shape was tested in a 1:1 model test during the shutdown period. As shown in Fig. 1, the relevant area of the tank wall with the welded bracket was copied true in detail and fitted with strain gages on both sides at the various transition points. The uniaxial load was then provided by a tensile testing machine as can be seen in the right part of Fig. 1. The strains that occurred on the original and on the optimized cross-sectional transitions were measured with strain gages, the positions of which can be seen in the left part of the figure. In the center part of the figure the reductions in the stress concentration are shown which were obtained due to the shape optimization and changes in operational practice. Just by changing the geometrical shape a reduction in the stress concentration of about 50 % was achieved. Reductions in

the stress brought about by a modification in operation are also shown.

The combination of the change of design and the change in operation reduced the local strains to 20 % of their original value. They were then acceptable for the magnetite coating. Regular testing in the last few years of operation has shown that no more cracks have occurred. This confirms the success of the applied remedial measures.
