Experimental determination of the load-bearing and deformation characteristics of the Flöhatal Bridge at Hetzdorf

by Reinhardt Günther and Dieter Schulze

Deck slabs in reinforced and prestressed concrete as used for railway bridges are being examined within the framework of an international research project. The measurement object in this article is the Flöhatal Bridge at Hetzdorf in Germany which was constructed as part of the project to straighten the railway line between Chemnitz and Dresden. Strains in the concrete and on the transverse reinforcement were measured together with deformation in the box girder cross-section, wheel loads from locomotives and various temperatures. The article describes the complex on-line measurement system with 87 measuring points for static measurements and 46 parallel measurement channels for the acquisition of dynamic signals. The main feature of the results is the comparison between the computed and measured results.

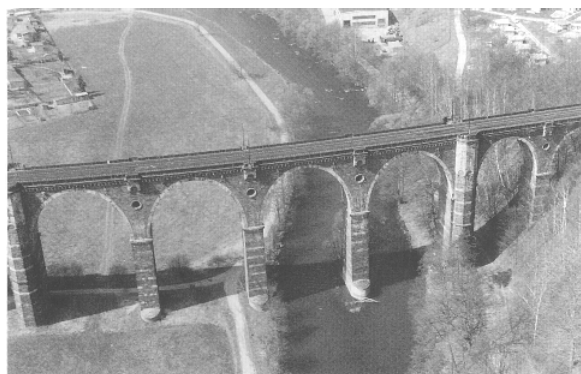
Fig. 1: View of part of the Hetzdorf Bridge which was built about 130 years ago.

Situated on the Dresden-Chemnitz railway line between the railway stations of Öderan and Falkenau there is a bridge, the Hetzdorf Viaduct, which was built in the years from 1866 to 1868. The two-track 326 m (357 yd) long structure is located in a bend with a radius of 750 m (820 yd); it is 43 m (141 ft) high and consists of four large and 13 small arches. **Figure 1** shows an aerial photograph of part of the bridge which is constructed from granite, sandstone and gneiss. Owing to its poor state of preservation, it is not able to fulfill the demands of rail traffic. Consequently, after extensive investigation of a number of alternatives, a new route was selected which would straighten out the line in the vicinity of the viaduct.

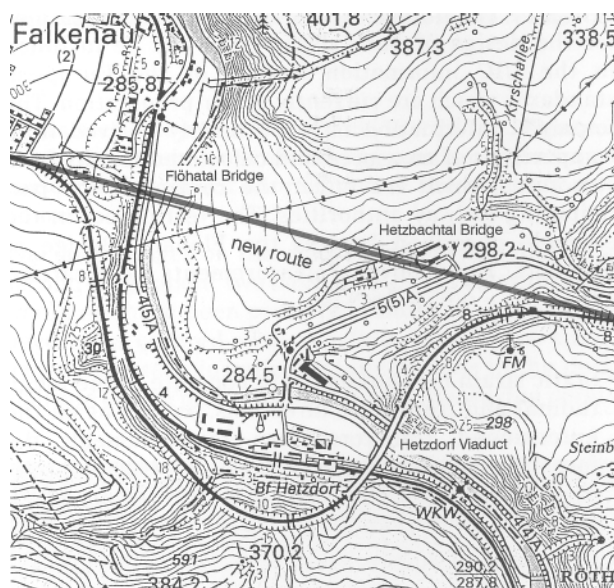
Fig. 2: Map showing the old and new sections of the railway line.

As can be seen from the map in **Fig. 2**, two new valley bridges had to be built along the line of the new route,

one over the Hetzbachtal and one over the Flöhatal. Designed before 1989, the two new bridges were the first railway bridges in the region of Germany now known as the "new federal states" to be built as prestressed continuous structures using the repeated push technique. The bridges were designed for a specified speed of 100 km/h (62 mph). A higher speed was not considered necessary due to the speeds in the sections before and after the new part of the route.

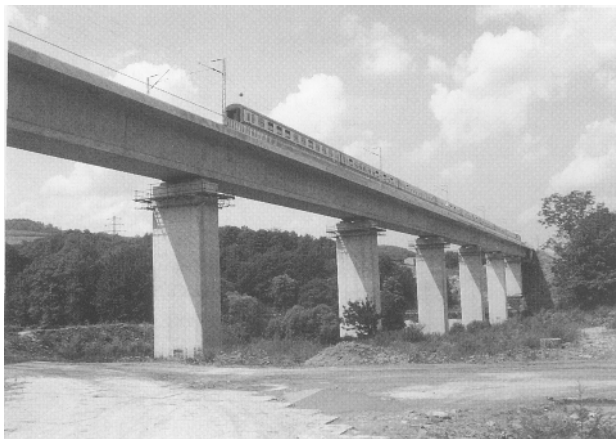
Fig. 3: View of one of the two new bridges.

The bridges - **Fig. 3** shows the Flöhatal Bridge - each have a length of 344 m (376 yd). The bridge superstructures are each supported on seven piers with heights between 15 m and 36 m (50 - 118 ft).

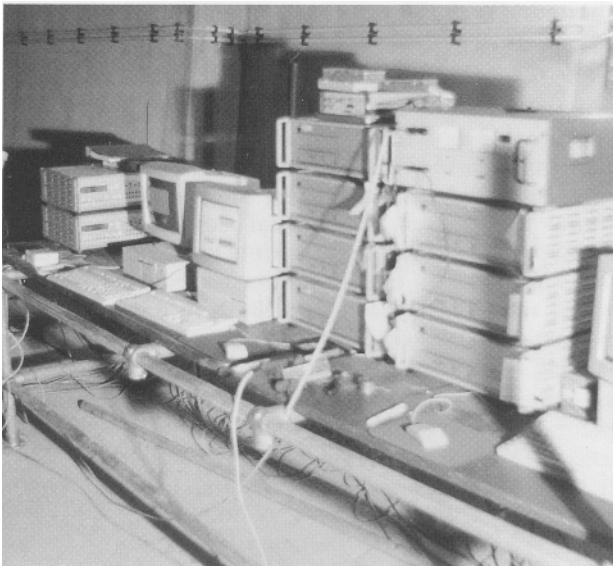
Fig. 5: View of the measurement system installed inside the bridge girder box.

Figure 5 gives an impression of the measurement system accommodated in the bridge girder box. To the left can be seen the two stacked UPM 60 Multi-Point Measuring Units and the DMC 9012A Digital Measuring Amplifiers in the right half of the picture.

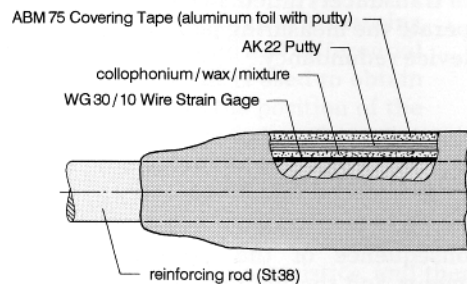
Fig. 6: Formation of the covering on the strain-gage measuring points fitted to the transverse reinforcement.

For the strain measurements the wire strain gages WG 30/10, which were at that time available from TPW in Thalheim, were used and configured to form full bridges. Special attention was given to the covering of the measuring points. The initial covering was a colophonium/wax mixture which had proved very successful in many measurements with the strain gages from Thalheim. A layer of AK22 Putty was then kneaded over this. Then a layer of ABM 75 Covering Tape, consisting of aluminum foil and putty, was applied. **Figure 6** illustrates diagrammatically how the strain gage was covered. The connecting cables for the measuring points were laid in conduit in the cavity in the girder box which was later available for the measurements

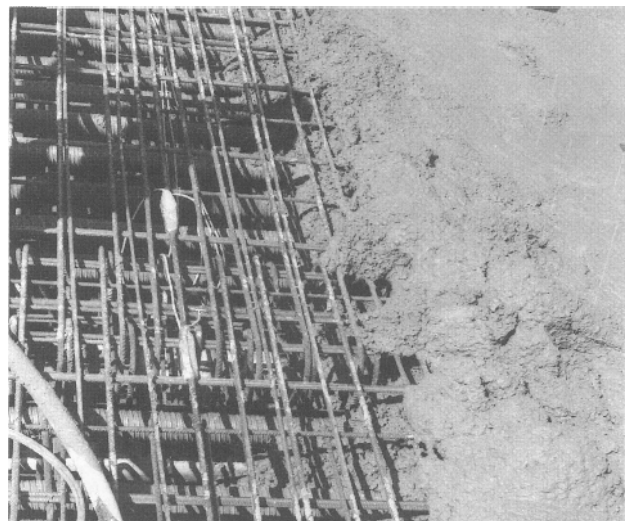
Fig. 7: View of the strain-gage measuring points on the transverse reinforcement shortly before the concrete was poured.

(cross-section approx. 4 m x 4 m [13 x 13 ft]). **Figure 7** shows two strain-gage measuring points on the transverse reinforcement shortly before the concrete was poured.

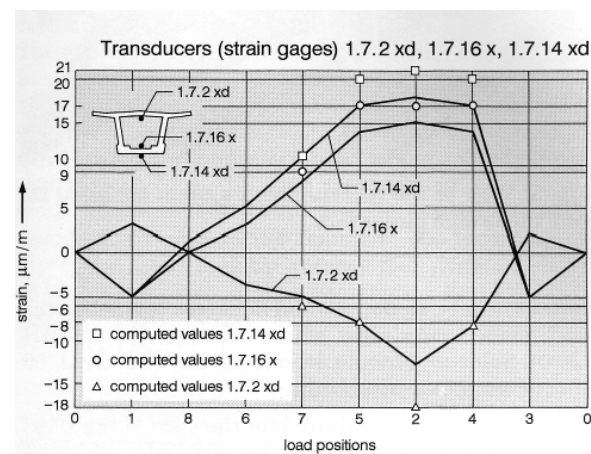
Fig. 8: Example of the comparison between the measured and calculated values based on strains measured with various load positions.

The strains and deformations were computed with an FEM model for selected load positions and compared with the measurement results. The agreement between the computed values and the measurements is very good when the measurement spread is taken into account. An example highlighting the comparison is

shown in Fig. 8. The measuring points 1.7.2xd, 1.7.16x and 1.7.14xd are taken here as being representative of the many statically measured values.
