Experimental determination of the stress in a plaster column dating from the 11th century and listed as a protected historic monument

Prof. Dr.-Ing. Klaus Steffens,
Institute for Experimental Statics,
University of Bremen and
Dr.-Ing. S. Keil*

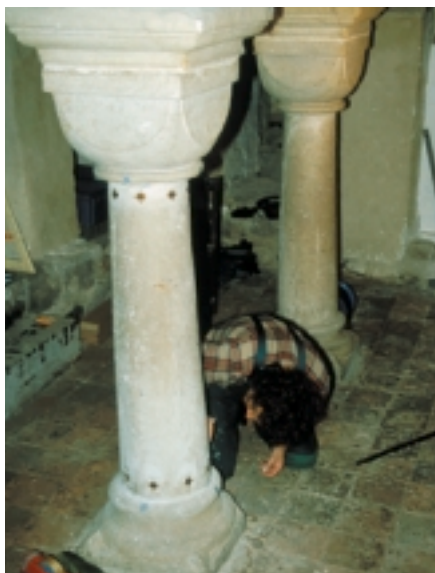
Fig. 2: View of the crypt during preparations for the experiment

A feasible method of testing the stability was to use strain gages to determine experimentally the effective marginal strains occurring at the top and base of a column due to loading and to compare the results with characteristic quantities applicable to the material composing the columns. The view showing the crypt during preparations for the experiment (Fig. 2) gives an impression of the columns.

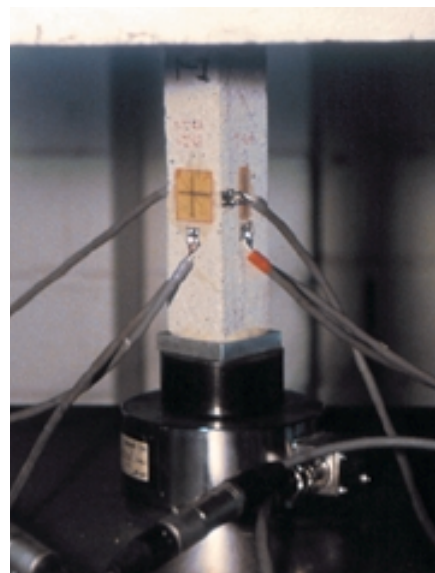
Fig. 4: Determining the characteristic quantities of a material from samples of plaster resembling the material of the columns as closely as possible

Characteristic quantities for the material were determined in advance by means of laboratory experiments on samples of new gypsum plaster with a composition which resembled the original material of the columns as closely as possible. This was achieved as shown in Fig. 4 by fitting strain gages to plaster prisms which were then loaded to breaking point with compressive force in a materials testing machine. The characteristic values for the column material determined as above and on which the planning is based are: mean Young's modulus $E = 16900 \text{ N/mm}^2$, lateral coefficient of expansion $\nu = 0.25$, compressive strength $f_{ck} > 18.8 \text{ N/mm}^2$ and breaking strain $\epsilon_{break} \approx 1500 \times 10^{-6}$.

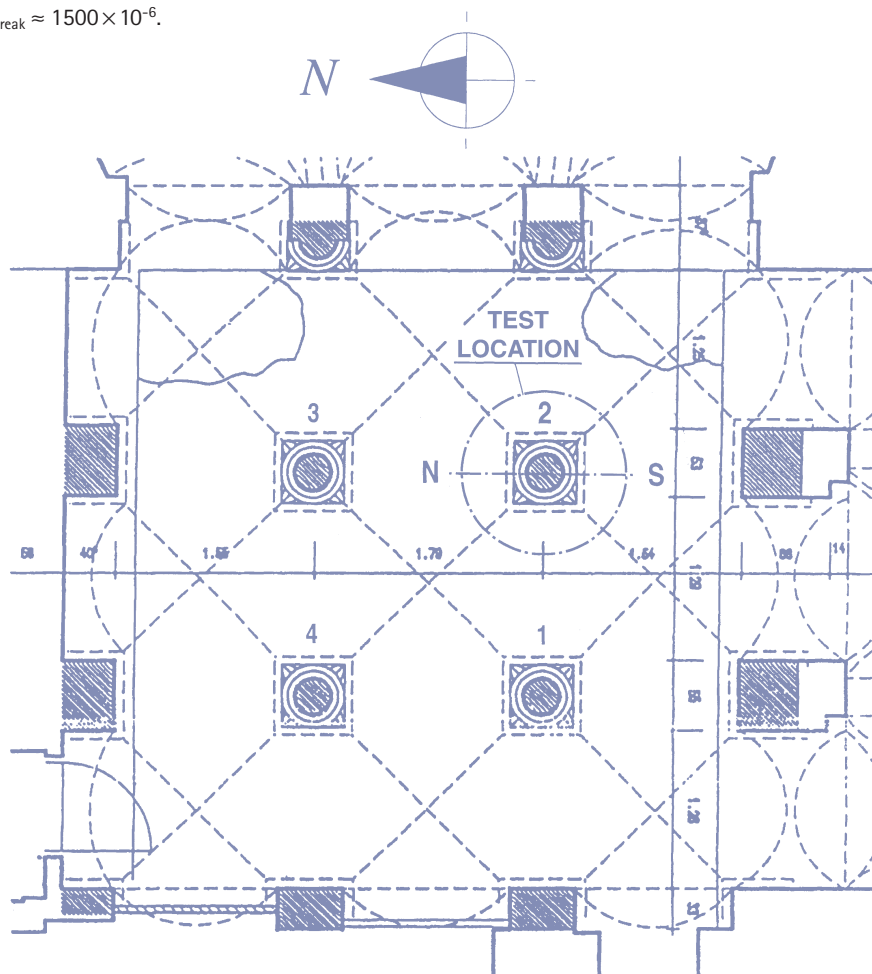
Fig. 3: Ground plan of the crypt showing the location of investigated column 2

To minimise cost, only one column was subjected to investigation. The column chosen was the one in the south-west corner of the crypt

shown as column 2 in Fig. 3, which emerged from the preliminary ultra-sound investigations [Lit. 6] as the most severely damaged of the four.

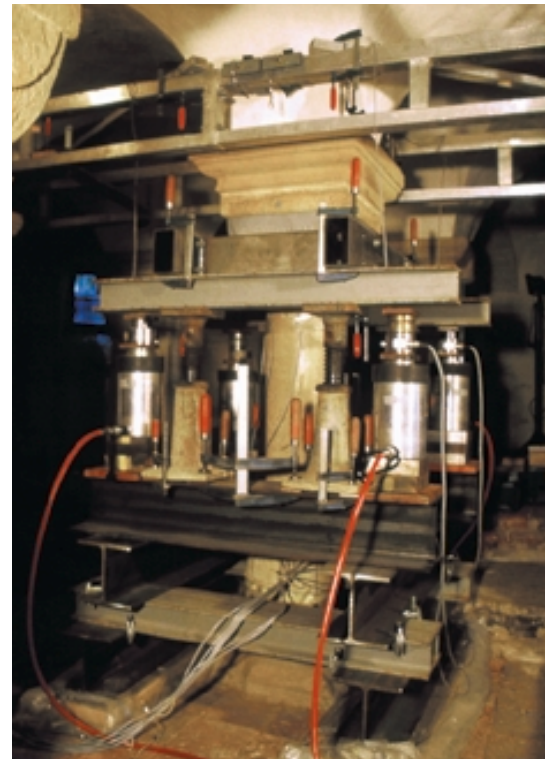
Fig. 6: The column complete with loading mechanism

The column was to be relieved of its load by lifting the capital. For this purpose a load conducting collar was manufactured to fit the carefully measured dimensions of the capital. The gap between the collar and the capital was

packed with cement grout without applying force. As a protective measure and to facilitate removal of the grout after the experiments, the surface of the capital was first covered with a textile membrane.

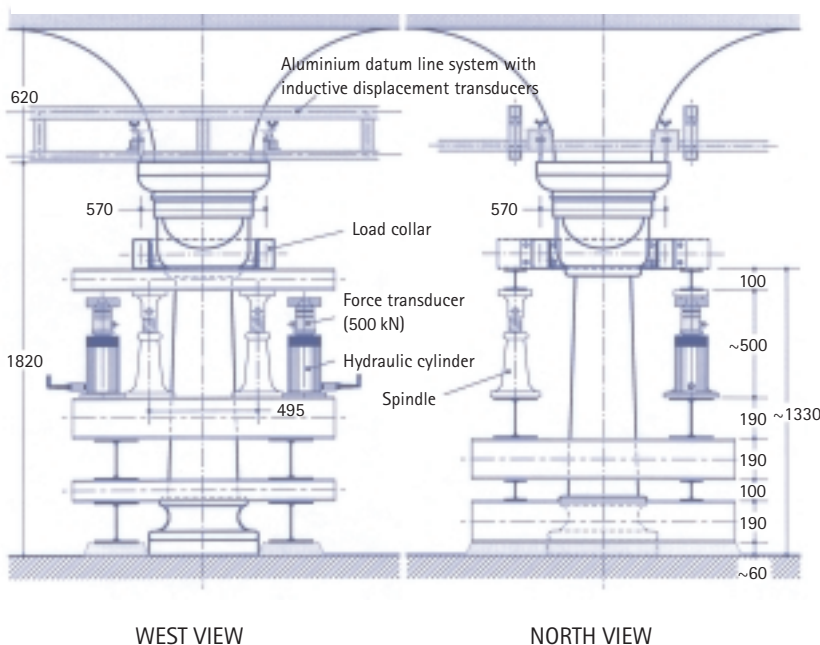
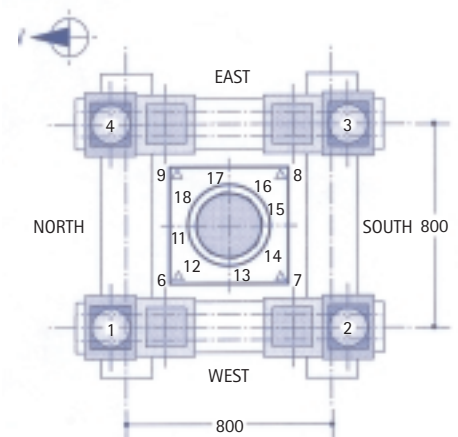
Fig. 5: Loading mechanism and test point plan

Measuring points:

- Force transducers 1 to 4
- Displacement transducers 6 to 9
- Strain gages 11 to 18 bottom 21 to 28

The lower part of Fig. 5 shows the positions of the force transducers at 1 to 4, the displacement transducers at 6 to 9, and the strain-gauge test points on the upper end of the column.

In order to shore up the downward load, two mortar beds were laid on membranes on the stone floor of the crypt. Steel bearers were placed on these mortar beds to act as a foundation for four hydraulic cylinders which would generate the upward force introduced into the load collar in order to lift the capital (Fig. 6). The force was generated with the aid of hand pumps. Fig. 5 shows plan and front views of the loading mechanism [Lit. 8].

To safeguard the capital from the possibility of a pressure loss in the hydraulic system and during a lengthy period of load relief, four continuously readjustable mechanical spindles were fitted parallel to the hydraulic cylinders to act as supports.

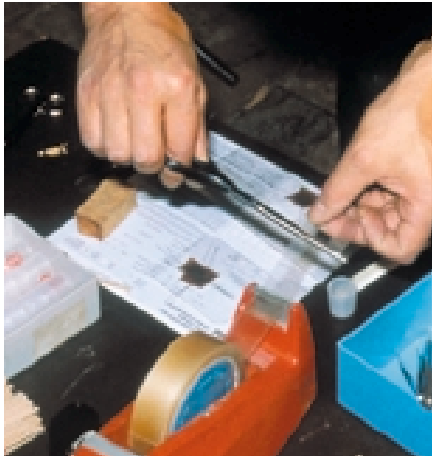
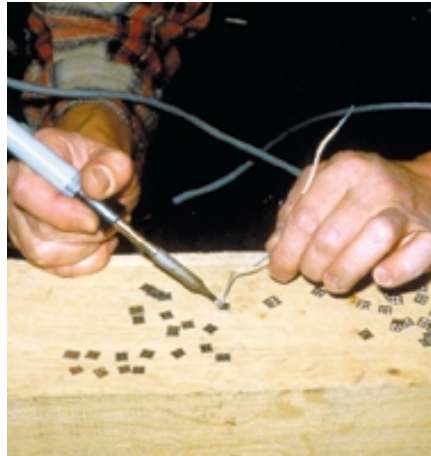
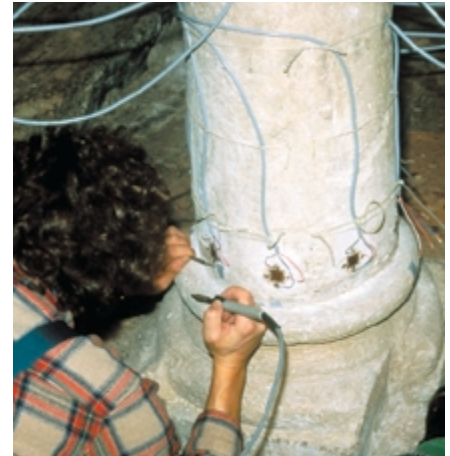
Fig. 7: Installing the strain gages

7a: Provisional space for preparatory work for installation

7b: Cleaning and pre-tinning the soldering terminals

7c: Installation work at the foot of the column

Installing strain gages demands special care and even in unfavourable external circumstances it is essential to create a clean space for preparation work in the immediate surroundings of the measurement place. Fig. 7a shows a view of the improvised work table set up in the crypt when preparing the strain gages for installation. Fig. 7b shows preparations for installing essential soldering terminals by cleaning the contact surfaces with a glass fibre brush and then tinning. Fig. 7c conveys an impression of the uncomfortable installation work at the foot of the column.

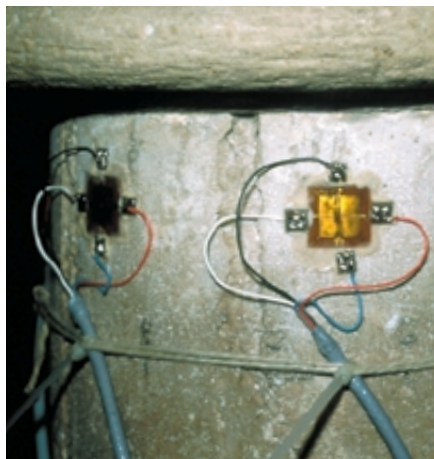
Fig. 8a: Measuring points on the upper edge of the column before masking, cord being used to relieve strain on cable connections

der to prevent it coming into direct contact with the surface of this historic column. Fig. 8a shows measuring points on the upper edge of the column following installation without their mastic covering. In order to relieve the strain on cable connections, cables were attached to the column with the aid of a cord tied around the shaft. Fig. 8b shows the measuring points after they have been carefully masked with AK 22.

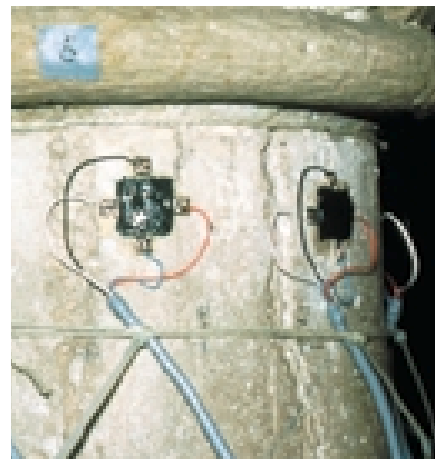
Fig. 8b: Measuring points after masking with AK22

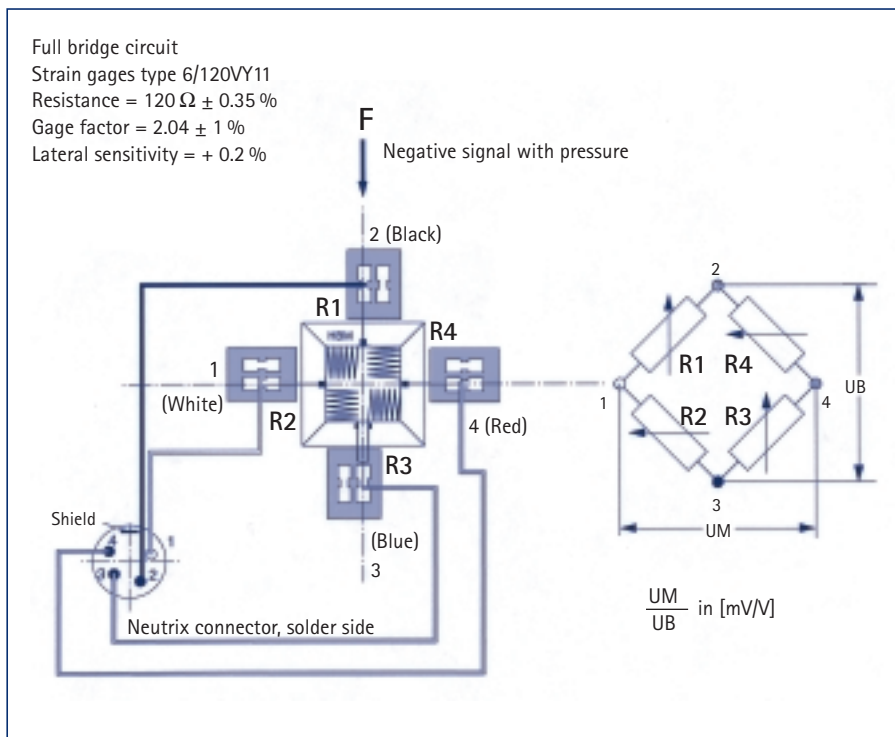
Fig. 9: Connection plan of an SG full bridge

Eight full bridge circuits with strain gages (type VY 11 6/120 manufactured by HBM) were installed on the upper and lower edges of the column, distributed uniformly around the circumference. Each of these strain gages held four lattices, two placed in the longitudinal direction and two transversely. These SGs cover a relatively large area and were chosen on account of the poor thermal conductivity of the material composing the measurement object. In preliminary tests using this type of SG on plaster it had been shown that no zero signal drift occurred due to possible internal heat within the strain gauge. Furthermore the full bridge circuit was easy to install in the case of each SG.

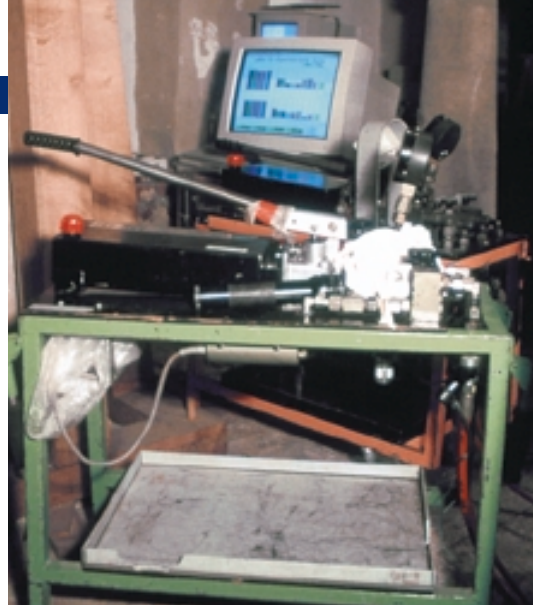
Fig. 10: View of the hand pump for generating pressure; in the background in the field of view of the operator is the monitor displaying measurement data online

After carrying out a zero balance on all measuring points, upward pressure was applied to the capital in 10 kN stages. Pressure was generated using the hand pump shown in Fig. 10. Measurement data could be observed online on the screen whilst the load was being increased so that application of the load could be halted at once in the event of anything untoward. The measurement results were printed out after each stage in increasing the load.

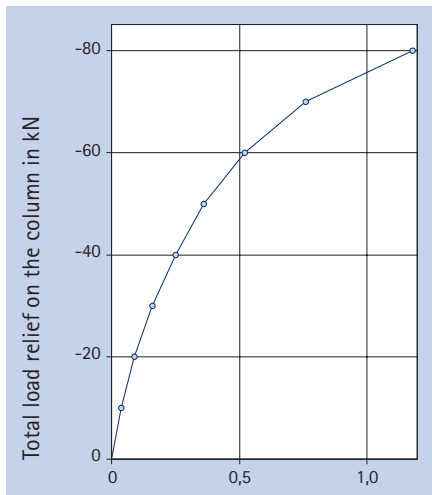
Following a baseline test and zero balance of the measurement unit, the capital was lifted in stages of 10 kN. After eight stages, at a total force of 79.7 kN, the capital had been lifted off the column until a full clearance existed and there was no contact whatsoever. In this state the average vertical displacement amounted to 1.18 mm. The maximum movement was measured as 1.23 mm at measuring point 7 (south-west corner) and the smallest as 1.14 mm at measuring point 9 (north-east corner), although the greatest compressive force was exerted there (20.4 kN). The average vertical displacement of the capital as a function of the total compressive force is reproduced in Fig. 12.

If the average strain on the upper column edge is represented as a function of the total load, as in Fig. 12, it can be seen that from about 64 kN upward there was no further change in the strain. This gives the total load imposed by the vaulting on the column under consideration as 64 kN to a close approximation. This is in close agreement with the value of 66.5 kN which was calculated in advance.

Fig. 12: Average vertical displacement of the capital as a function of the load relief on the column

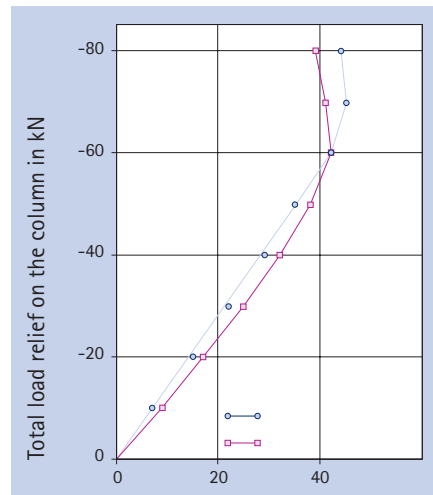
Fig. 13: Average strains at the upper and lower ends of the column as a function of the load relief on the column

Fig. 13 shows the average strain values measured for the load relief procedure at the upper and lower column edges as a function of the total force. The curve is linear until just before the point of load relief is fully reached. If these average strain values and the stress arising from the force per column cross-section are used to calculate the Young's modulus of the column material at the upper end, the calculated value of $E = 28,428 \text{ N/mm}^2$ is significantly higher than the value determined in the preliminary laboratory investigations where $E = 16,900 \text{ N/mm}^2$ on samples of new material. Doing the same for the lower end of the column, the average strain values in the linear section and the larger cross-section give a Young's modulus of $E = 15,181 \text{ N/mm}^2$.

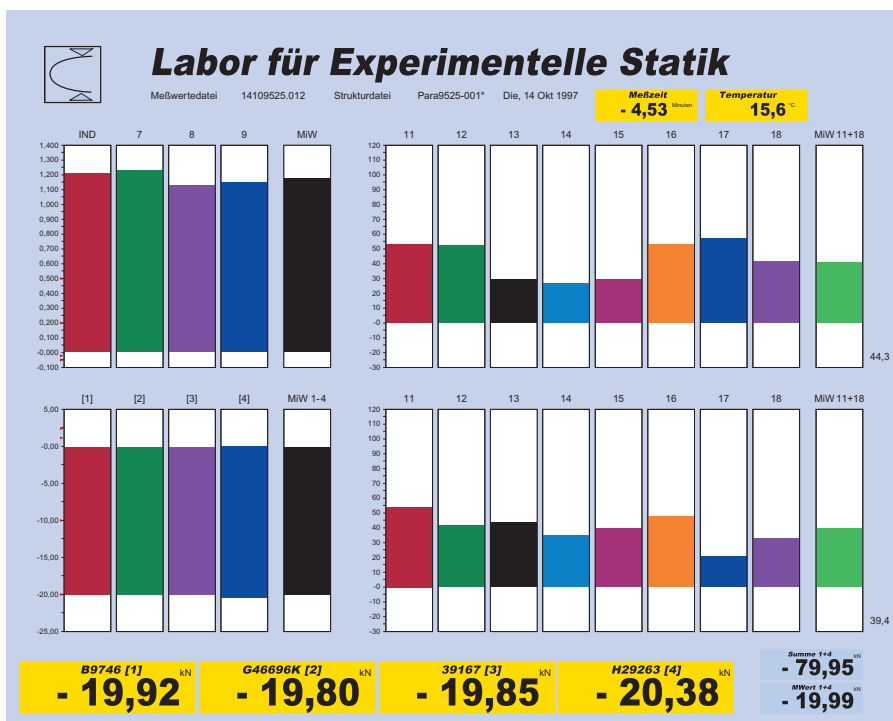
Fig. 14: Monitor screen with online display of the forces, displacements and strains measured at the moment the column was totally relieved of its loading

The measurement results were displayed online for the entire duration of the investigation. Fig. 14 shows a view of the screen at the moment the column was totally relieved of its loading. The details of the display are as follows: the lower line shows the digital values in kN for the four forces on the hydraulic cylinders together with their total and average values; top left is a bar diagram showing the displacement in mm at the four corner points of the capital and their average value; lower left is a bar diagram of the four forces acting on the hydraulic cylinders and their average value.

At upper and lower right the strains in $\mu\text{m}/\text{m}$ on the eight measuring points at the top of the column and at the foot of the column are displayed along with their respective average values. Finally the top line of the screen shows: the file name, the name of the structure file, the date, time and duration of the investigation, and the temperature in the crypt.

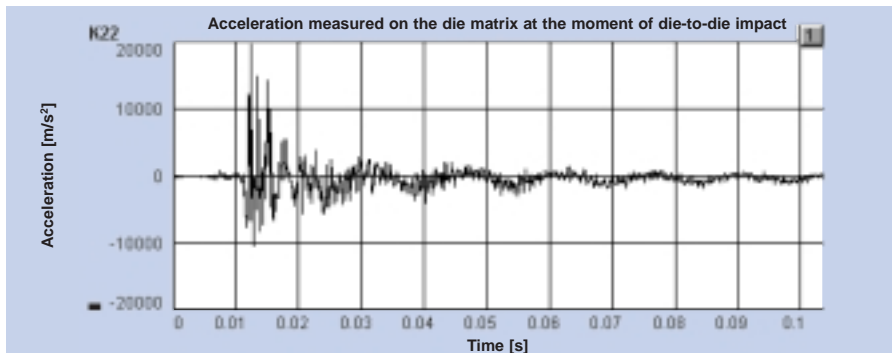
Fig. 2 shows the die fitted in the hammer immediately after a forging stroke. It is impossible to fasten the wires with clips since the fastenings break after a few impacts on account of the high acceleration at the die (higher than 20000 m/s², Fig. 3).

Fig. 3: Acceleration at the test die as a function of time

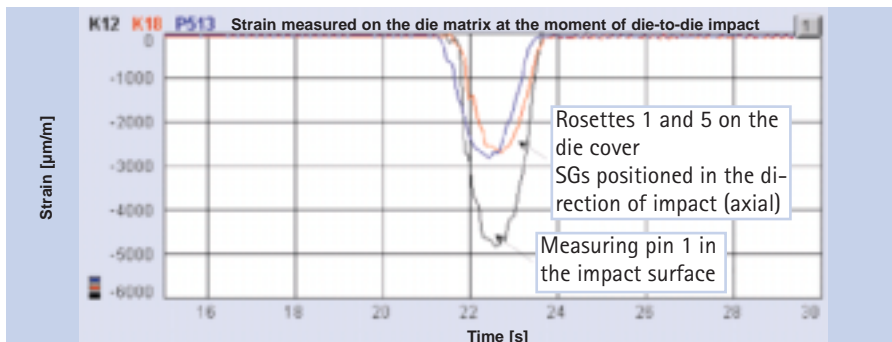
The other plots in Fig. 4 show the response signal, measured at the die cover in the direction of impact (axial), on two SGs attached at different heights. This signal can be used to adjust the FE model. Fig. 5 shows the stress distribution calculated with the aid of the measured force trends at the instant when the greatest reference stress according to Von Mises occurred. The greatest stresses occur in the radius of curvature of the die joint.

Fig. 4: Strain at the test die as a function of time

At the end of the series of impacts the deformation resulting from contact between the impact surfaces is close to that for die against die (duration of die-to-die impact approx. 2 ms). Fig. 4 shows the strain signal from a measuring pin in the impact surface. This signal can be used as input for the FE computation.

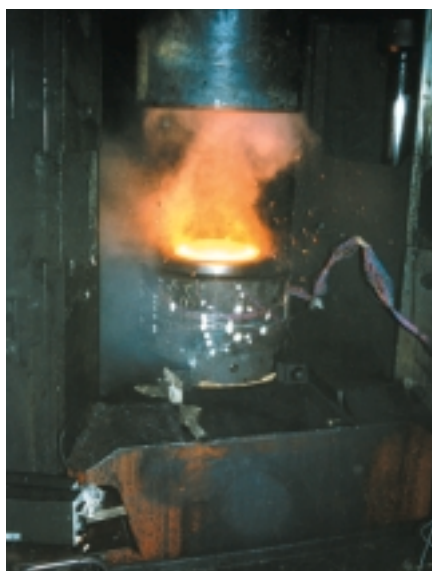
Fig. 2 The test die after an impact
