# Deployment of an optical sensing system for monitoring an underground water supply pipeline

**ABSTRACT:** The present study concerns a fibre Bragg grating (FBG) based structural monitoring system installed on a water supply pipeline in Sydney, Australia. This paper presents the details of the implemented monitoring system including hardware and software. It discusses the use of FBG optical technology, that was chosen due to its advantages in the water-filled pressurized environment and the requirement for rapid installation. It also documents the transducer solution that was developed, the architecture of the optical sensing network, the data handling process from measurement to the real-time visualization, and the challenging installation performed during the shutdown window. Most significantly, this project demonstrates the feasibility of deploying such a system and provides relevant insights from two years of monitoring including opportunities for improvement.

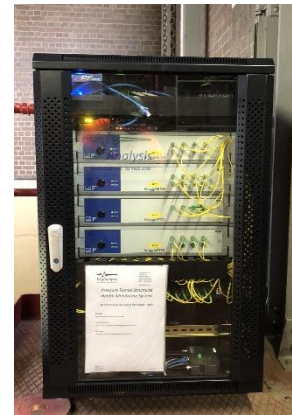
The data acquisition system consisted of 4 optical interrogators – FS22 BraggMETER SI – with 8 and 4 optical channels and an acquisition rate of 1 sample/s. The FS22 BraggMETER units were mounted on a rack as shown in Figure 5.

Figure 5. Server rack.

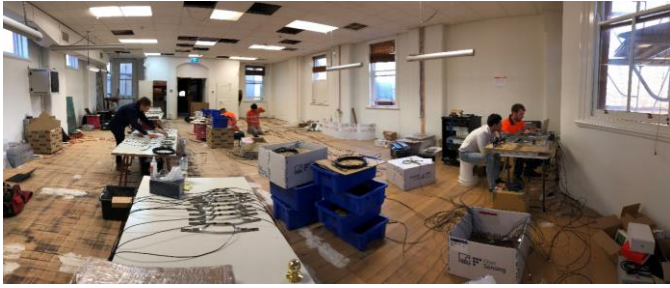
The splices were potted for waterproofing and the cables and sensors were bundled in boxes ready for deployment. To meet the delivery timeframe, all aspects of hardware and software development were occurring in parallel. The assembly and calibration process are illustrated in Figure 7. The optical cables selected for the system are AFL Global multi-core tactical cable.

Figure 7. System assembly works.

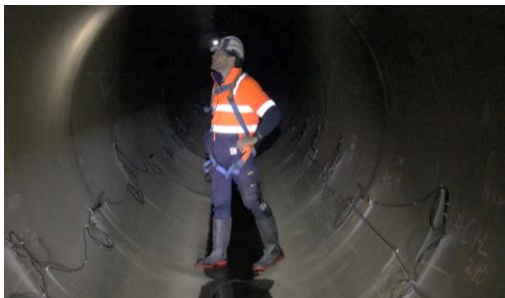
After 5 days, a team of five engineers plus confined space tradesmen were able to install all sensors. An example of the installation environment is presented in Figure 9. All the sensors were checked and confirmed to be operational when the access to the pipeline was closed and the pipe filling commenced.

Figure 9. Installation site

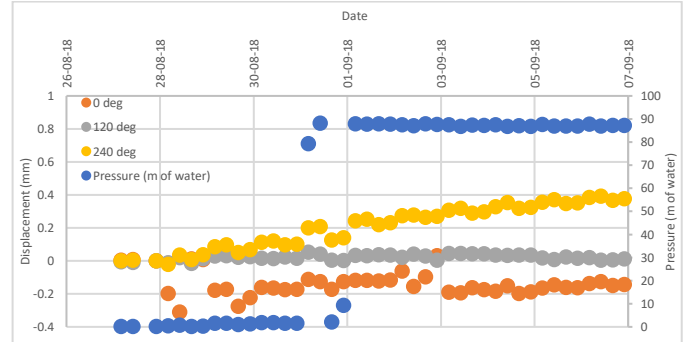
It was anticipated that an initial displacement at the joints would be observed during the pipe-filling process. The dramatic increase in pressure experienced by the pipe did not create a sudden change in joint displacement, as indicated in Figure 10.

Figure 10. Pipe displacements during refill.

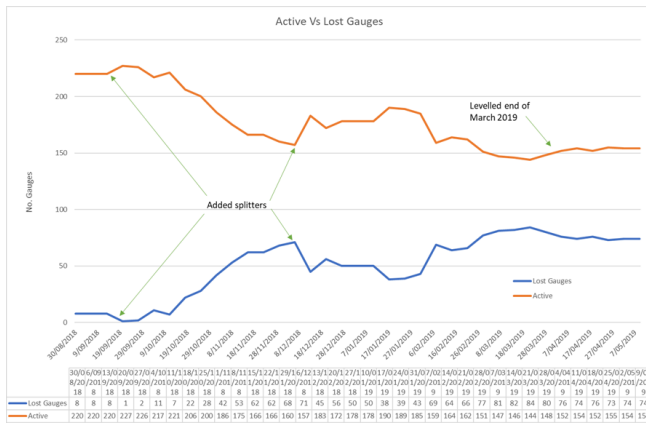
Once the system was fully submerged, the signal from some sensors started to vanish from the optical spectrum. Being an optical array with multiple sensors on a single cable, occasionally whole strings of sensors started to fail. The installation process had connected both ends of the strings to the surface and some of the sensors were recovered by means of interrogating from the other end of a cable string. This feature is possible due to redundancy inherent to the reflective wavelength detection technology. As seen in Figure 12, after a significant loss of sensors experienced during the first months, the system levelled out after 6 months. After two years of operation, approximately 65% of the sensors are active and reliable. Without being able to access the site it is unclear the cause of the failure, but it is believed that the in-factory splices and the coiled cables are the most likely cause of the failures. For future projects, it is highly recommended that the factory

Figure 12. Active and inactive optical sensors for the first 9 months of operation.

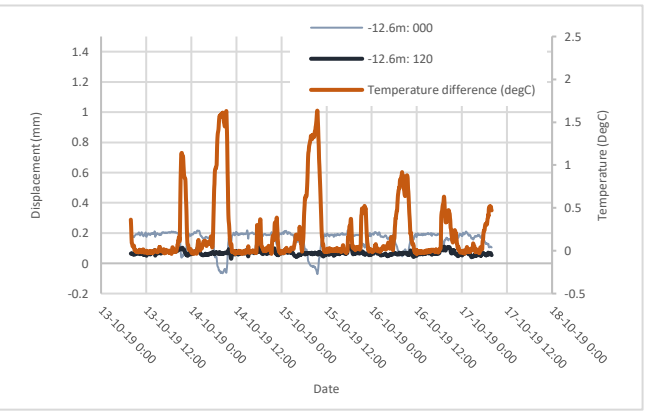
After a year of operation, the overhead (0°) sensors started to record low frequency periodic oscillation occurring at regular times of the day on both joints and hoop sensors. It was found that the asset owner was injecting supplementary water from a desalination plant to supplement the reservoir water during the peak demand periods as indicated in Figure 13. The desalination plant derived water is warmer than the reservoir derived water. The desalination plant point of injection was more than 2km upstream of the measurement point and it was concluded that the relatively low water flow rate allowed thermal stratification within the water column. The upper sensors were consequently responding to the warmer water and not physical displacement.

Figure 13. Calculated temperature difference between top and bottom sensors.

In the design phase it had been assumed that the water column would be well mixed and the temperature reference for each regional area was located in the lower section of the pipeline. This observation highlights the susceptible to the influence of thermoclines in the water column differentially effecting the sensor output. These observations provided evidence of water-source stratification and may explain why some distribution lines are more susceptible to alteration in
