Monitoring the settling of the river pier supporting the Inn valley expressway bridge at Kufstein, Austria

by Martin Aschaber

Erosion of the bed of the River Inn at Kufstein led to the sudden settling of an expressway bridge. The bridge was part of an important international communications link and its prompt repair was eagerly awaited. One problem for the engineers involved in the repair work was the monitoring of the settling of the bridge. The author describes the measuring method used which comprised a differential level monitoring system based on interconnected water vessels.

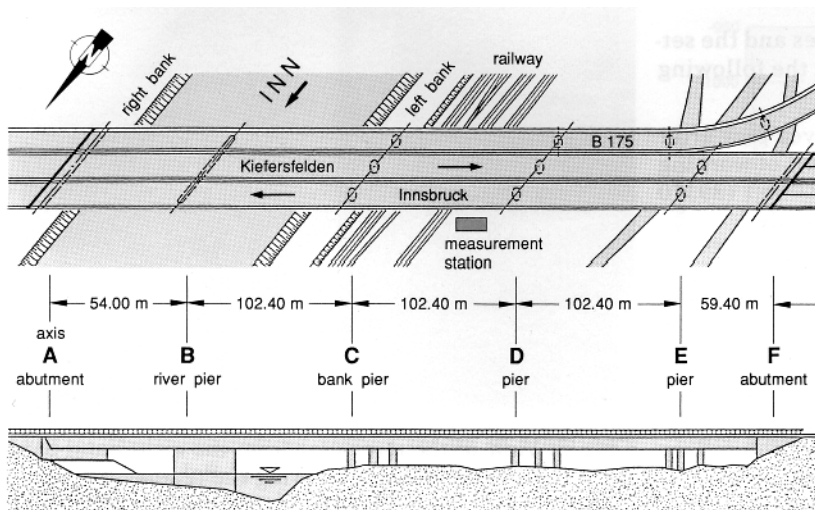
Fig. 1: Plan and elevation of the bridge over the River Inn at Kufstein; the bridge consists of three separate reinforced-concrete box girders

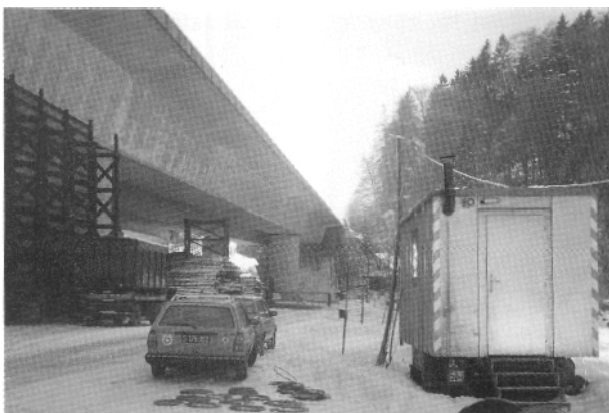
Fig. 4: The measurement station set up in a builder's trailer on the left bank of the river; the auxiliary supports for the girder can be seen in the left of the picture

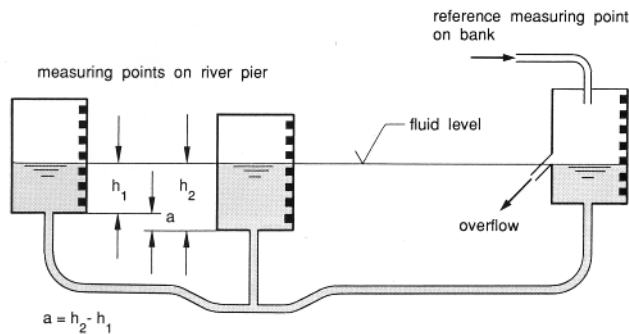
As illustrated schematically in Fig. 6, a water level system exploits the hydrostatic principle of communicating tubes for making level measurements. In engineering applications the tubes are replaced by measuring vessels. A reference vessel is located on a firm base on the bank. A feed and overflow system maintains a constant level of the measurement fluid in the reference vessel. The levels of the fluid in the separate measuring vessels, which are joined to one another and to the reference vessel by pipes, indicate the same level throughout. If a measuring vessel sinks due to downwards movement on its fixture (settlement of the pier), then the fluid level remains at the same level as before, but the fluid level rises relative to the vessel. The change in level is a measure of the settlement that has occurred. A

Fig. 6: Diagrammatic representation of the principle of the water level system

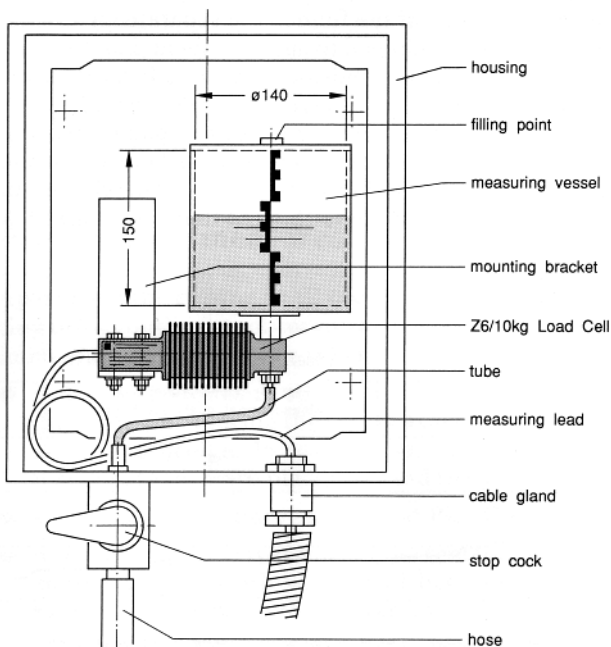
Figure 7 diagrammatically illustrates a measuring vessel used in the water level system. Loads cells of the type Z6/10 kg were used. After deciding to install this type of water level system, the utmost speed was needed in setting it up and there was no time for non-essential optimization. Excellent cooperation developed out of the emergency situation between the large number of people, companies and organizations involved. All components for the level monitoring system had to be designed, produced and installed in the shortest possible time. It was thanks to the efficient cooperation between those involved that the water level system was installed and able to supply its first measurements on 1st August

Fig. 7: Arrangement of a measuring vessel in the water level system; the vessel is mounted on a load cell for gravimetric level measurement

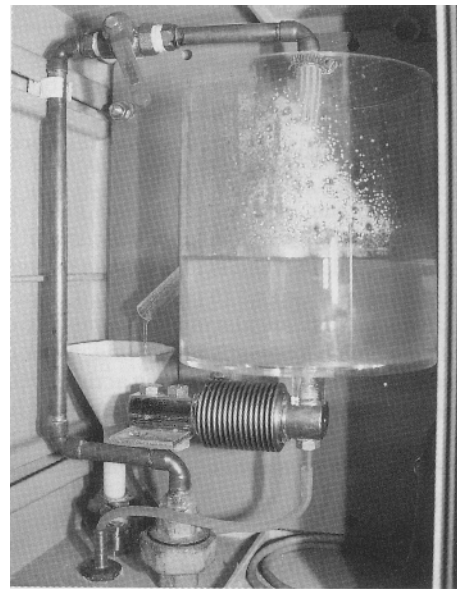
1990. **Figure 8** shows a photograph of the reference vessel with the feed and overflow. **Figure 9** illustrates a photograph of the vessel arrangement for Measuring Point No. 1.

Fig. 8: Reference point measuring vessel with feed and overflow, mounted on firm ground on the river bank

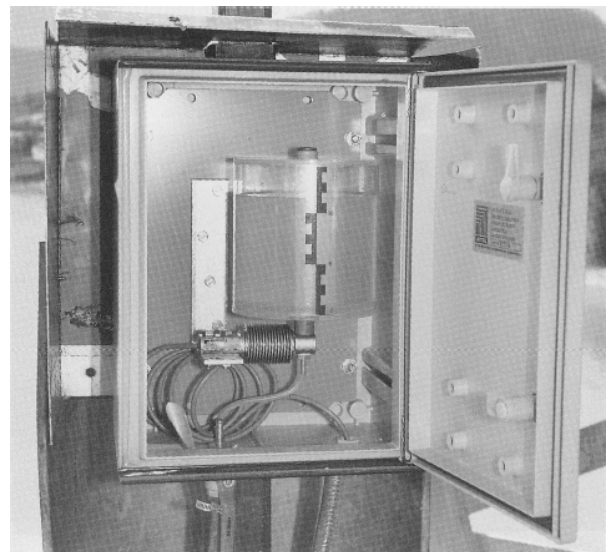
Fig. 9: Vessel arrangement at a measuring point on the river pier

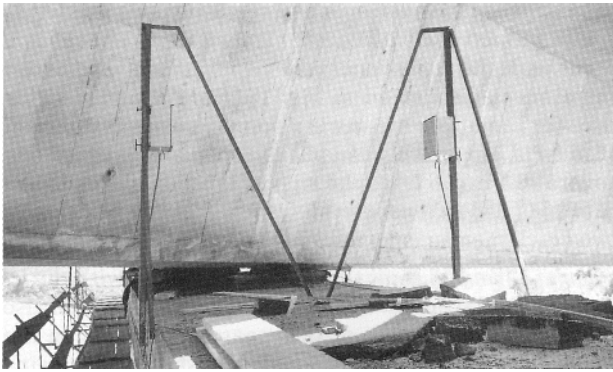
Fig. 10: The measuring points for the water level system on the nose of the pier were mounted on extruded rods

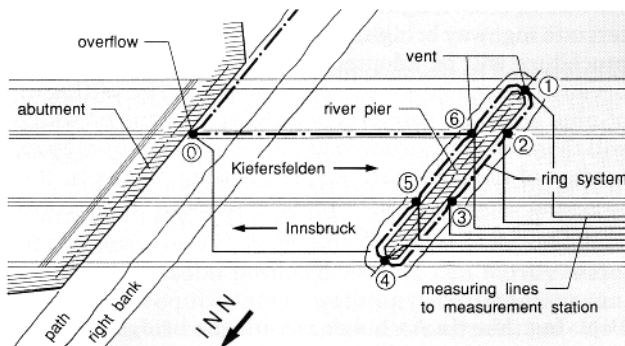
Figure 11 shows the arrangement of the six measuring vessels on the river pier in a plan of the measuring points. Originally, only four points were intended. However, due to the crack in the pier, two extra measuring points (1 and 4) were installed in order to have three points on each segment of the pier. A 1/2" steel pipe provided the hydraulic connection between the reference measurement point on the river bank and Measuring Point 6 on the pier. The ring system connecting the six measuring points consisted of frost-proof garden hose. A mixture of water and glycol was used as the measurement medium.

Fig. 11: Plan showing the location of the measuring points in the water level system

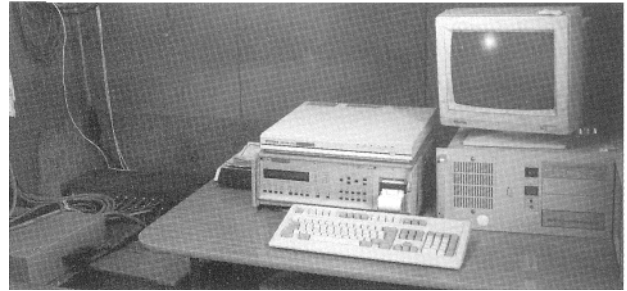
Fig. 12: View in the measurement trailer of the UPM 60 Multipoint Measuring Unit which is connected on-line to a personal computer

ing points. The scale factors for the separate measuring points differed slightly due to tolerances in producing the vessels and due to the mounting of the vessels which was not absolutely vertical. The UPM 60 was connected on-line to a computer and to the alarm control unit. **Figure 12** is a view of the interior of the measurement container, the UPM 60 and the computer. The connection board for the measuring leads can be seen on the left in the background and the housing for the alarm equipment is also shown.

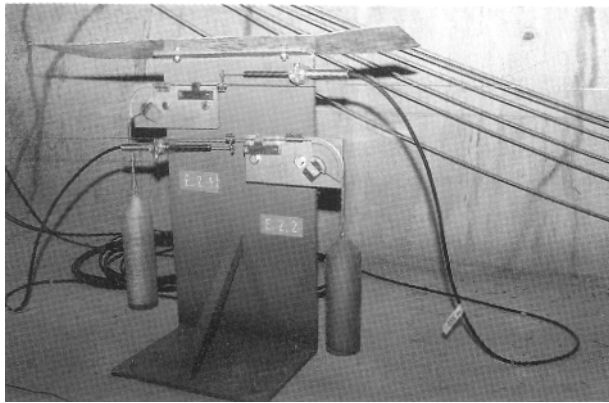
Fig. 15: Wire extensometer measuring point; the changes in the measurement lengths covered by the two Invar wires are measured by two inductive displacement transducers

the changes in length over the measurement section to W 20K Inductive Displacement Transducers. The tension point with the transducers for two of these wire extensometers is illustrated in **Fig. 15**. Here the measuring wire for the upper measuring point covers a distance of 18.7 m (61.4 ft) to the left and the wire on the lower one covers 20.1 m (66 ft) to the right. **Figure 16** shows the location of this extensometer system and the position of two crack measuring points in the bridge.

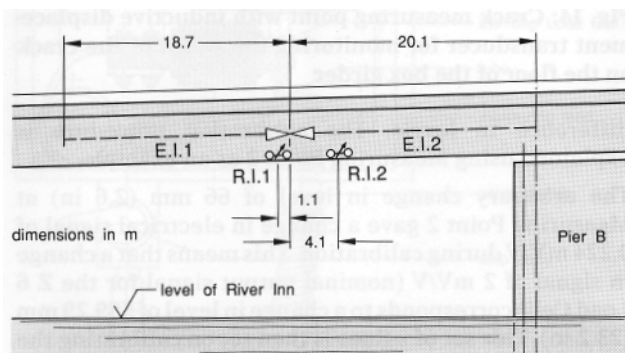
Fig. 16: Example of the arrangement of the extensometers and crack measuring points in the box girder of the lane in the Innsbruck direction
