Melbourne, Australia - October 2014

Test, redesign and construction of a new water cooling pump slab bench

CELLS-ALBA

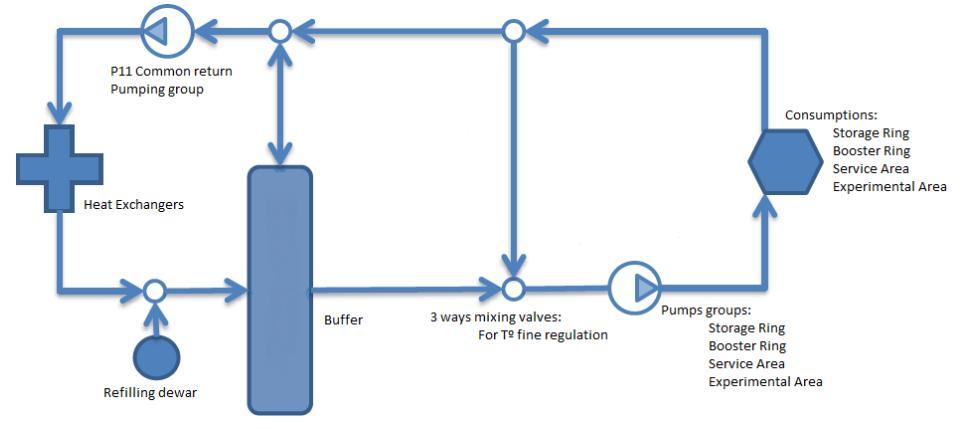
Fig. 1. Water cooling sketch.

The ALBA deionized water cooling system is based on a main common return which collects the four cooling rings, storage ring, booster, service area and experimental area. Consequently the common return circuit needs a huge pumping unit, P11, which deals with all flow of the whole cooling system. Figure 1 shows a basic sketch of this cooling system. This pumping unit is supported by means a vibration isolation slab bench which includes two identical pumping units, the working one and the redundancy for system reliability, Figure 2 shows the current slab design.

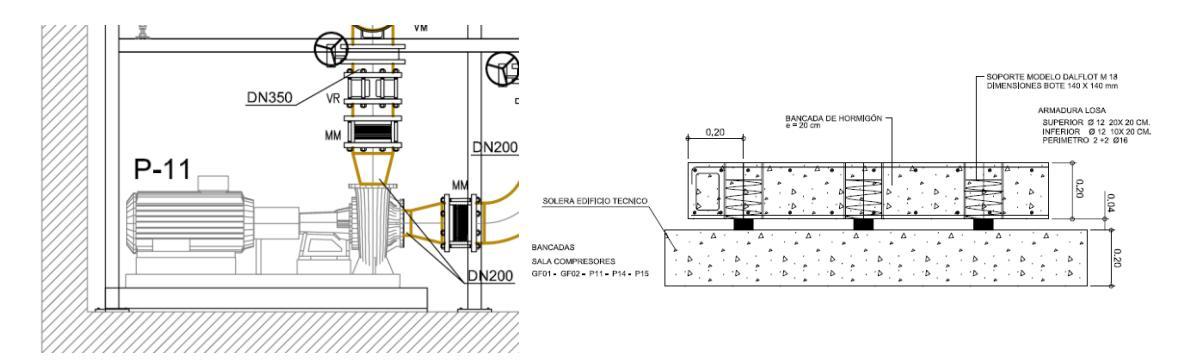
Fig. 2. a. P11 pump unit lay-out. b. Water pump slab bench design.

In fact the slab is quite thin, in relation of the whole slab dimensions, and it was suspect that the forced vibration excitation of the motor-pump unit deforms to much the labs or even the natural frequencies of the mechanical system based on the pumps bench slab were beaten with the asynchronous motor rotation at electrical net driving frequency. Following figure 2 shows the sketch of the design of the pumping system.

In order to figure out the stability the bench the system has been reconstructed in 3D models. This model has full details of the steel reinforced concrete slab including the core steel reinforcement. It also includes a base steel frame on the slab top as mechanical interface where the unit is mounted. This frame is a flat rectangular shape "plate" which is empty inside. In the Figure 2. a. can be seen the concrete steel frame as well as the steel base frame between the slab and the motor-pump unit in the Figure 2. b.

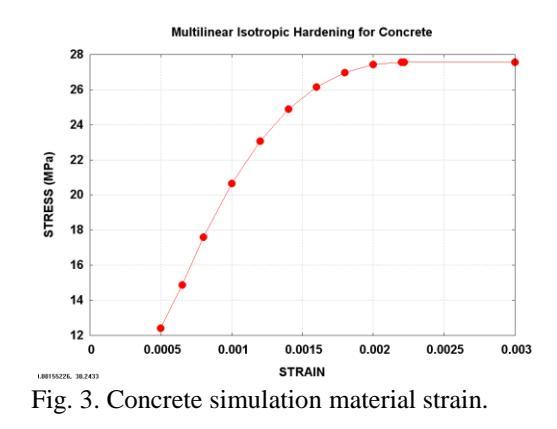
- The concrete is simulated by a special material which has a flat strain beyond certain limit of stress simulating the low traction resistance of the concrete. Figure 3 shows the concrete
- The reinforcing concrete frame is simulated by one-dimensional beam element which has the reinforcement rod cross section at each element.
- The 3D mesh nodes of the concrete around the steel rods are linked to the one-dimensional beam nodes.

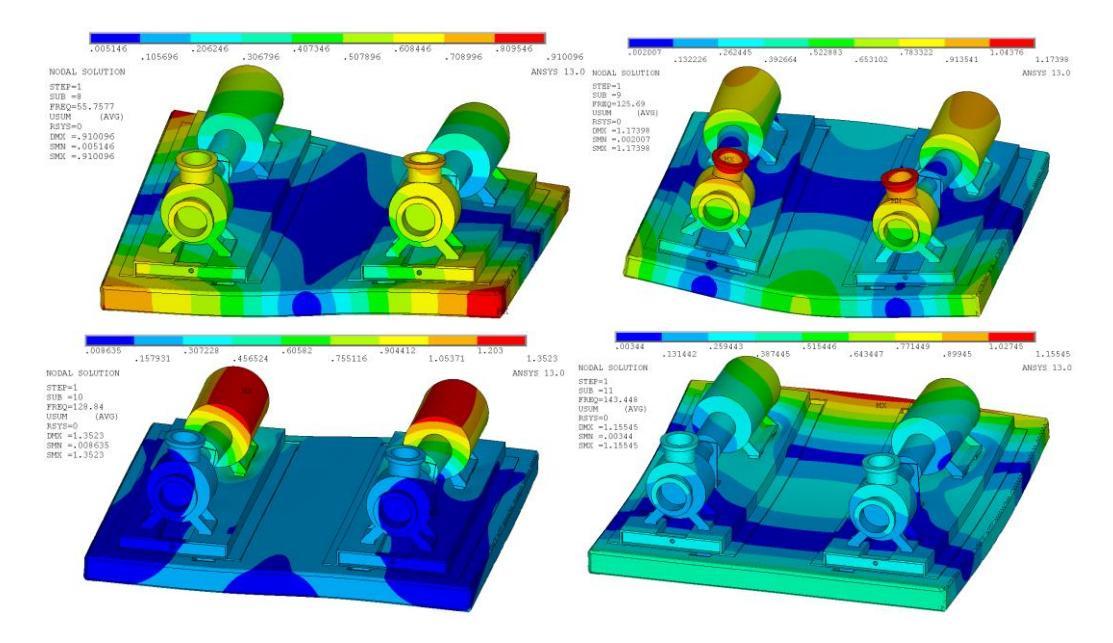
With this the simulated resonance modes are shown in the next Figure 4.

Fig. 4. FEA calculated natural frequencies.

- We have slab resonance modes very close to pump typical working condition which are at 50 Hz for conventional electrical network motor connection and between 40 and 50 Hz with the motor driver that this system has.
- All resonances are due flexion deformations which would means the slab is seems to be too large for the mass and overall dimensions compared with the thickness.

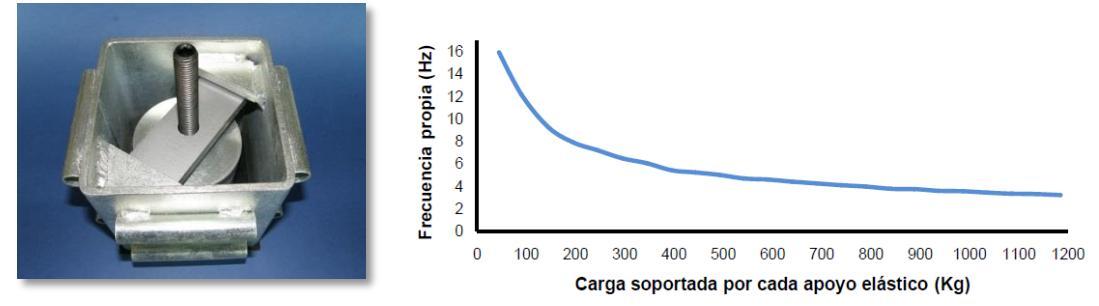
The slab lies on standard vibration isolation pads, taken into account the mass system it is expected to vibrate at about 4Hz following characteristic graph of the supplier. Next Figure 5 shows these pads, Figure 5. a. and its rigidity curve, Figure 5. b.

Fig. 5. a. Standard Isolation pad. b. Rigidity curve

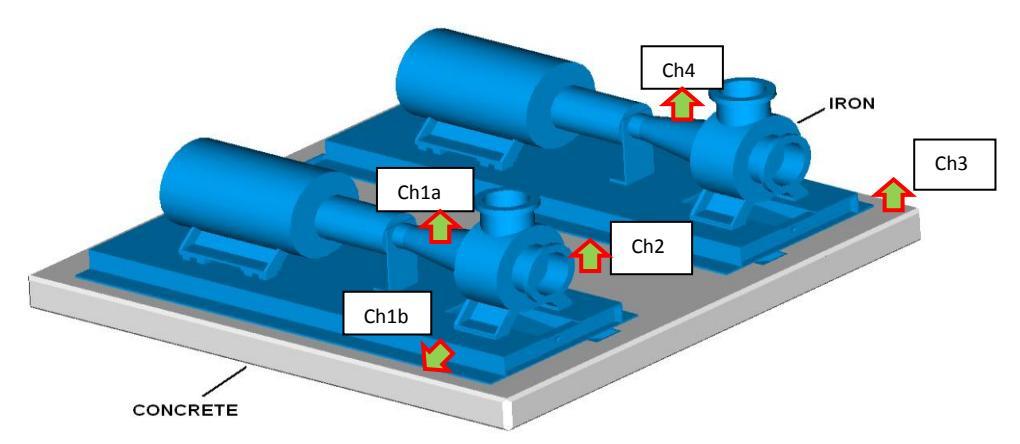
In order to fix the diagnosis of the problem a vibration measurement campaign was done. This was performed by means single axis accelerometer placed on the slab. Figure 6 shows the position of the accelerometers during the measurement, the arrows, and the arrow pointer shows the orientation of the accelerometers.

Fig. 6. Measurements accelerometers position and orientation

The first measurement are done with all accelerometers oriented vertically as shown in the Figure 6 and with the accelerometer number 1, channel 1 (Ch1a), on the pump.

As all the resonances are supposed to be flexion deformation modes a measurement thus with the accelerometer placed horizontally would give much lower signal. Taking advantage of this a second measurement with the channel 1 placed horizontally was done; Figure 6 shows this position as Ch1b and its orientation. The results of this measurement are shown in next Figure 9:

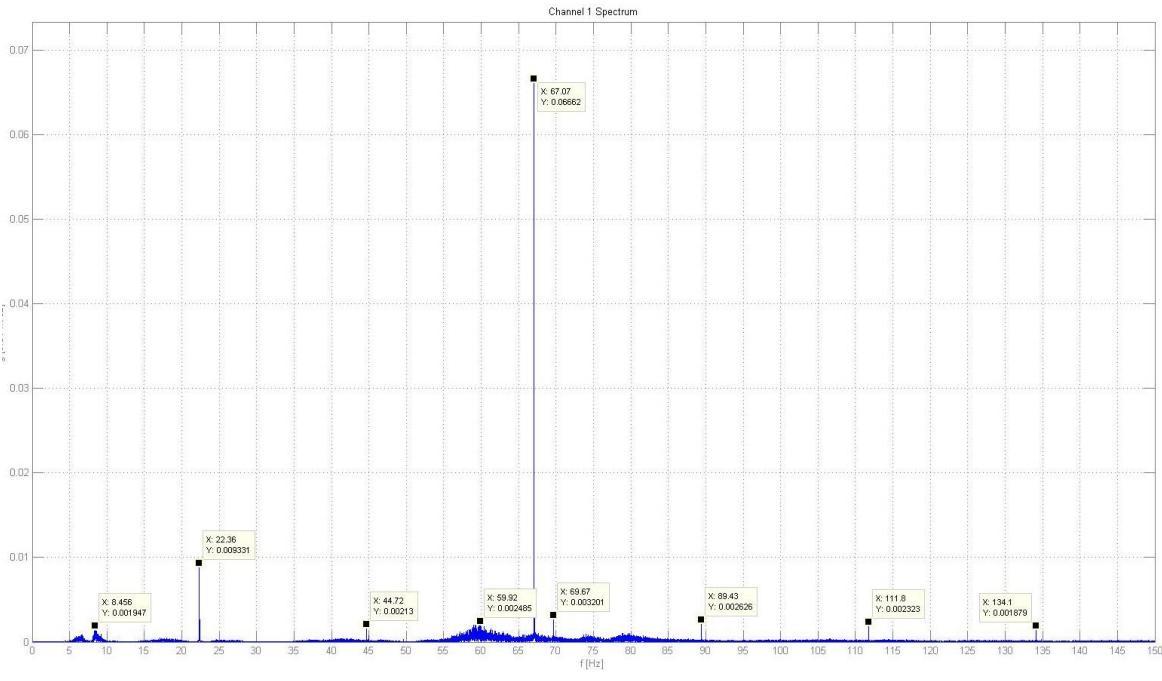
All channels are very similar in response. Next figure shows the as it measures the excitation source and is one that have the highest values.

Fig. 7. Measurements channel 1 spectrum

The asynchronous motors harmonics are the more monochromatic peaks. As there is a three-phase electrical power supply the frequencies of excitation are the 50Hz harmonics of the electrical net installation being this the more relevant. The pumps have pumping regulation by means frequency drivers so the excitation frequency is given by:

With this the main excitation frequency is: 25 Hz (for 50 Hz of electrical power supply) as the motor is a four poles engine. As the motor driver is adjusted in a fix point temporarily for commissioning at 45Hz the motor excitation harmonics are multiples of 22,5Hz which in the measurements corresponds with multiples of 22,36Hz: 22,36Hz, 44,75 Hz, 67,08Hz, ... The small difference between the driving frequency and the rotation frequency is the slicing of the asynchronous motors.

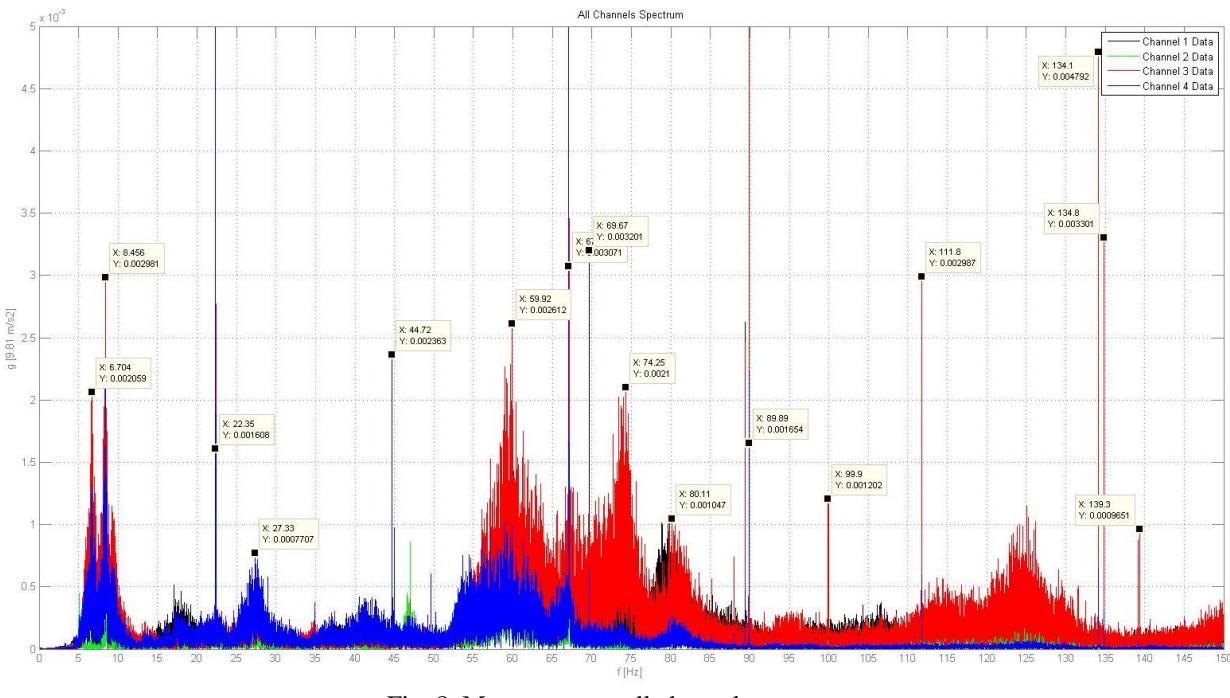
As the third harmonic is hardly amplified is suspicious to be close of a resonance mode. Doing a zoom and including all channels it is obtained following Figure 8.

Fig. 8. Measurements all channels

With this clear zoom the resonance modes can be clearly seen and are summarized in the next Table 1:

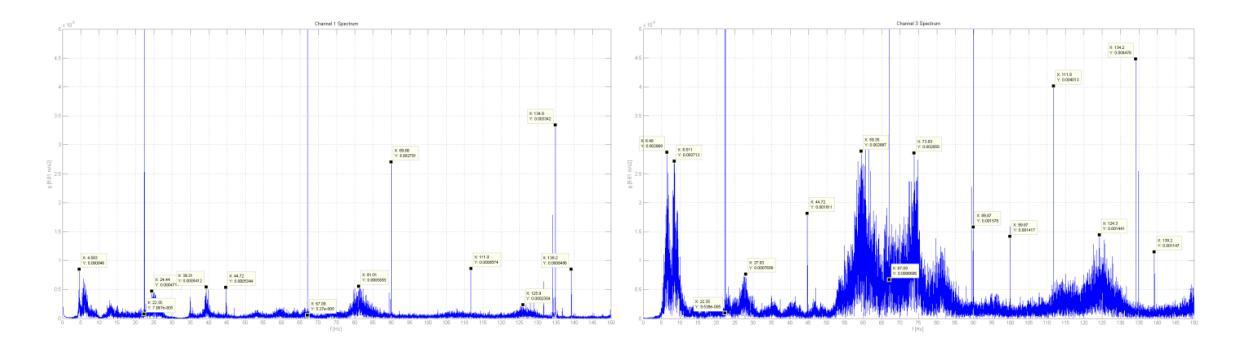
Figure 9. Channel 1 & 3, with channel 1 place horizontally.

The comparison with channel 1, horizontally oriented, and channel three on a slab corner where is supposed to have higher signal is clear most of the peaks has disappear or in most of the cases the signal is much less significant. This confirms previous peaks as resonance modes, flexion one as shown in the simulation.

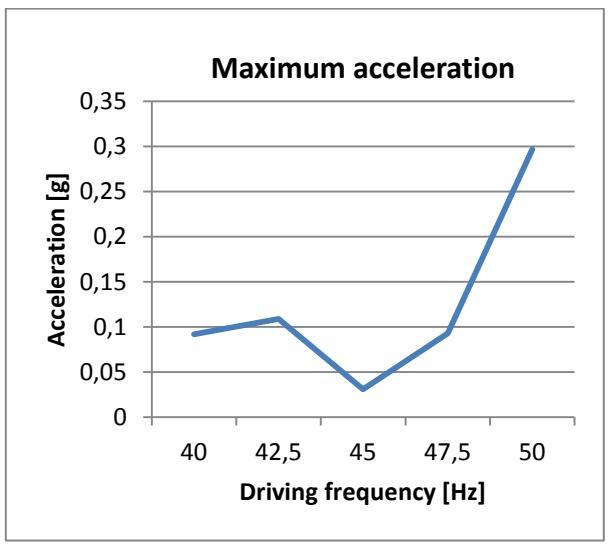
Next figures, Figure 10 and Figure 11, show the acceleration system response to the excitation at the different driving frequencies. Although the total power of the motor increase and it is partially the origin of the acceleration rise up shown in the graph of the Figure 10 it is clear that one harmonic, 3rd one, is moving from the first resonance, 59.92 Hz, to a safe regime where there is a clear acceleration valley, at 45Hz, and from here to the second resonance, 74.25Hz. This is clearly shown with the acceleration rise up as in addition the second and third excitation harmonics are beating simultaneously the two first resonance modes.

Figure 10. Acceleration as function of the driving frequency

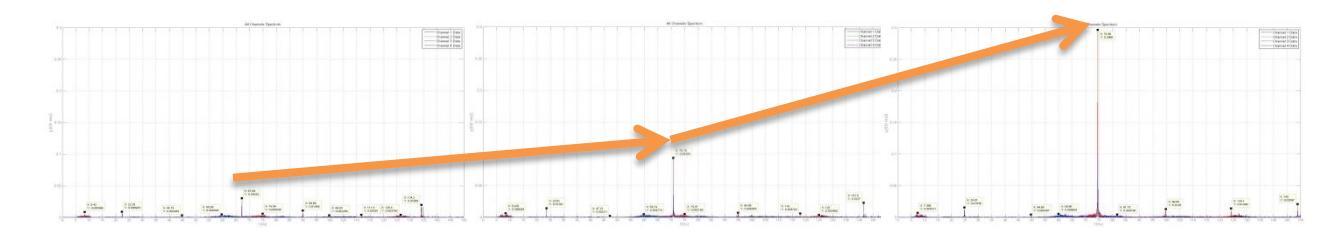
Figure 11. Acceleration as function of the driving frequency from 45 to 50 Hz.

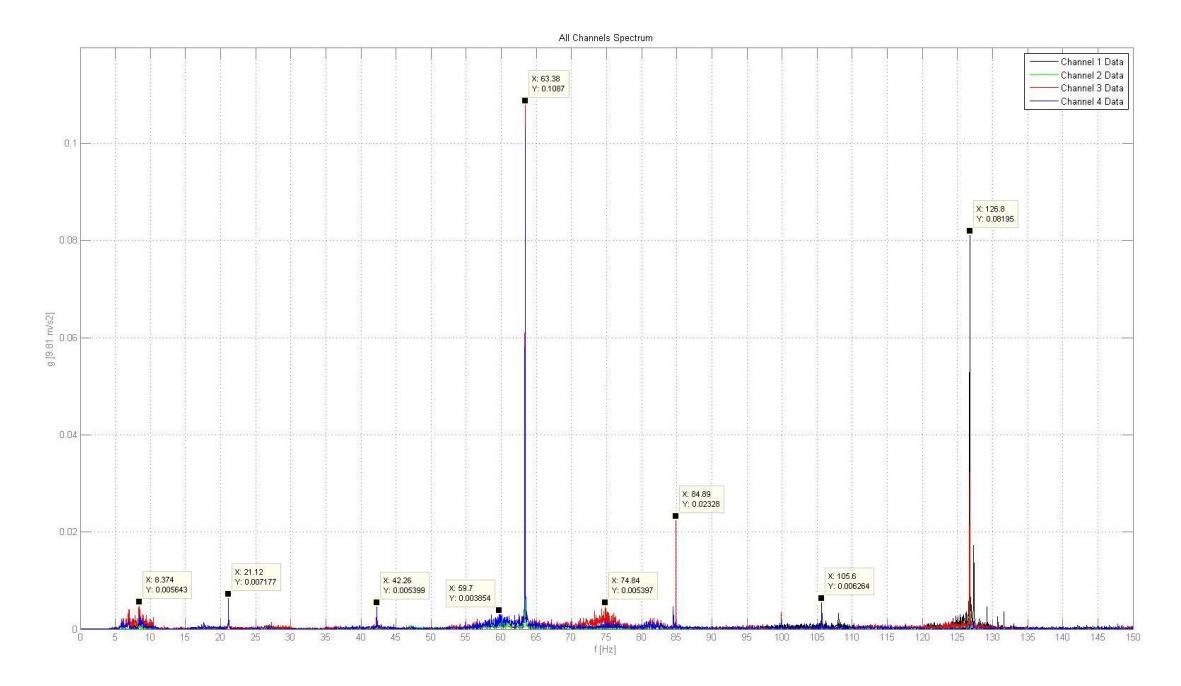
During the scan experiment at driving frequency of 42,5 Hz, the sixth harmonic, 127,5 Hz is very close to the supposed 125,1Hz fourth resonance mode, and this is clearly shown with the amplification of this harmonic in the next Figure 12.

Figure 12. All Channels at 42,5 Hz

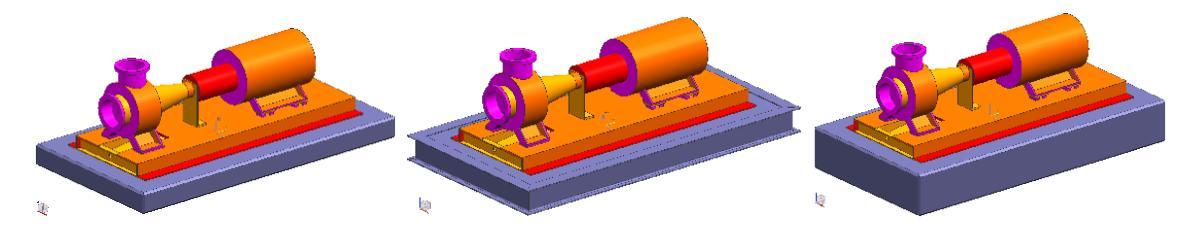
These three cases will give and idea of the improvement that each change will introduce independently. Next Figure 13 shows the three options

Figure 13. a. Current split. b. Mark frame reinforce. c. Thick slab

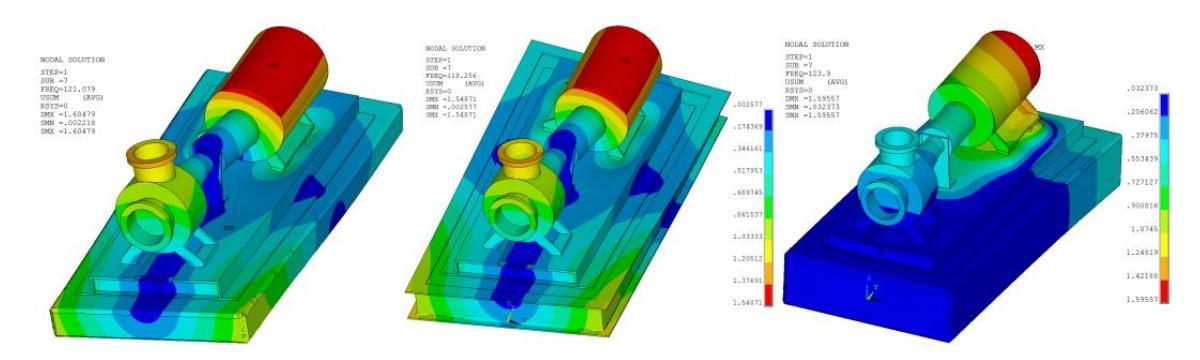
And the result is shown in next Figure 14

Figure 14. Three options first resonance mode, steel frame empty

All three first resonance modes are around 120Hz despite the significant differences between the three proposals.

This is due steel base frame, between the concrete and the motor-pump, on the *slab is empty*:

- It is the weakest point, it is clearly shown in the Figure 14 the last subfigure.
- Thus it is the main contribution at the first resonance mode
- And acts as in series spring connection to the rest of the slab
- This hides the rigidity improvements of the concrete slab of the different options.
- New calculation has been done:
- Refilling FEA meshing it with concrete
- Refilling FEA meshing it with steel

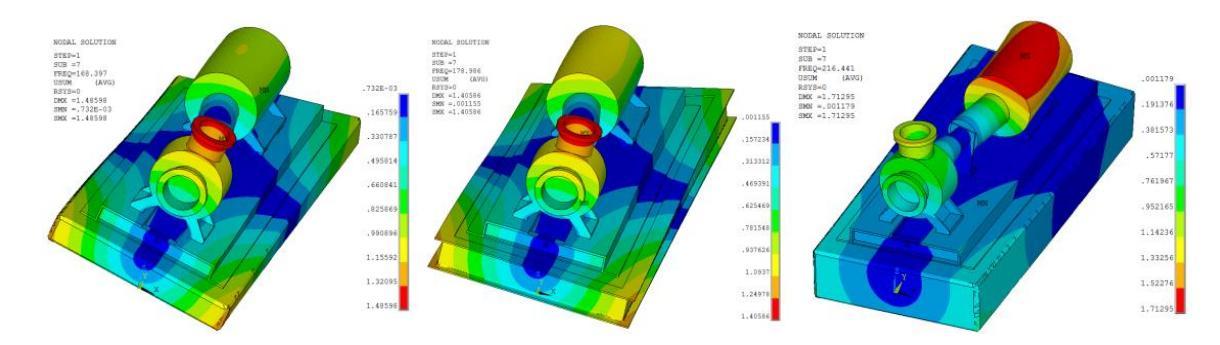
And the result is shown in next Figure 15

Figure 15: Three options first resonance mode, steel frame fill

With this it is clear that the best solution it is to increase as much as we can the thickness, but this is very limited due the dimensions and the geometrical constrains of the water pipes, thus the new design is based on:

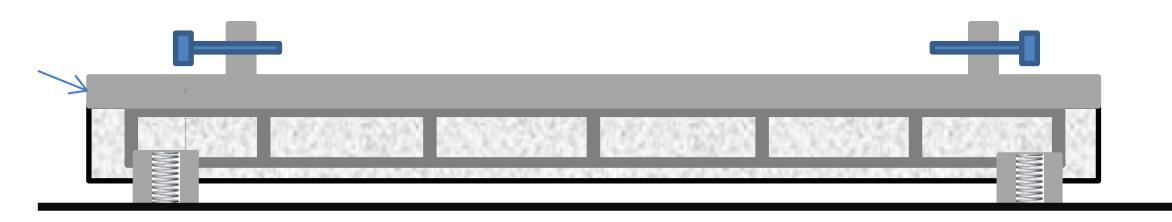
With this previous consideration the conceptual proposal is like shown in the Figure 16:

Figure 16. Prototype conceptual solution

- The new slab remove some big shims under the motor-pump to increase the total height
- A new top big plate is introduced instead the empty steel frame:
 - \circ Increases the rigidity
 - Introduce a flat mechanical surface
 - For proper accurate mechanical interface on the motor-pump fixation point.
 - For easier system realignment.
 - Lateral pushing screws are introduced for friendly motor and pump alignment.

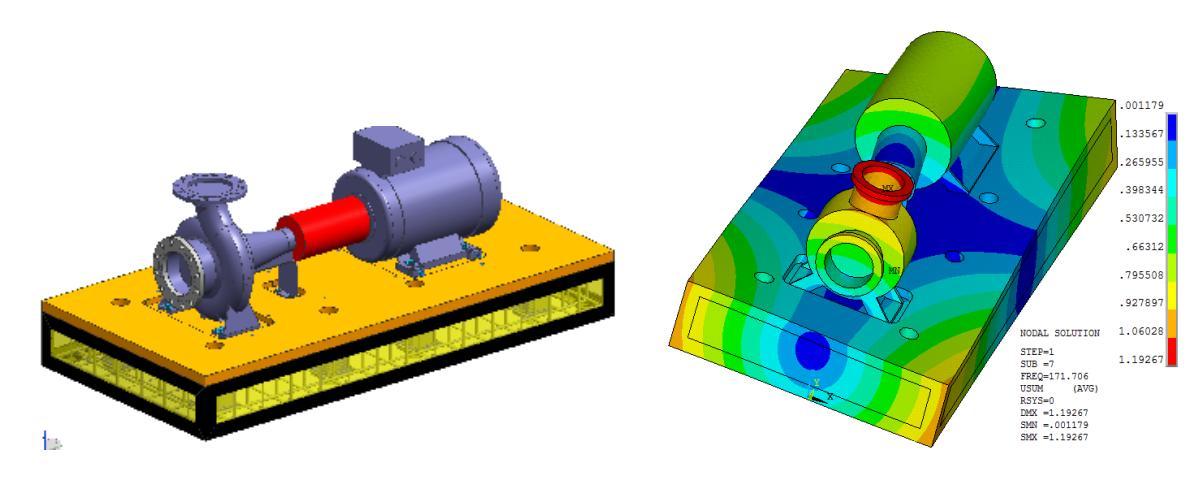
Following Figure 17 shows the final design and the first resonance mode simulation

Figure 17. a. Prototype design. b. Prototype fine simulation

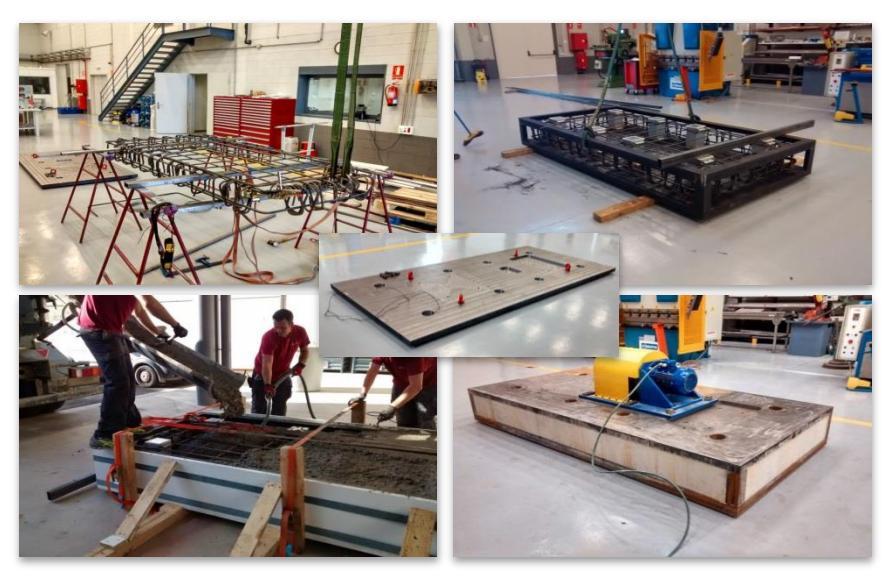
The first new design prototype has been full in-house constructed. ALBA workshop has prepared the formwork for the concrete mold. Next Figure 18 shows the production steps:

Figure 18. Prototype production

This prototype has been tested by means a shaking machine to test the vibration behavior. This engine can be seen the last picture of the previous Figure 18. About 8 measurements have been done doing a frequency scan test all them showing the same result. This measurement has been done by means two different configuration: with and without eccentric mass on the shaking machine wheel. The results are the same but:

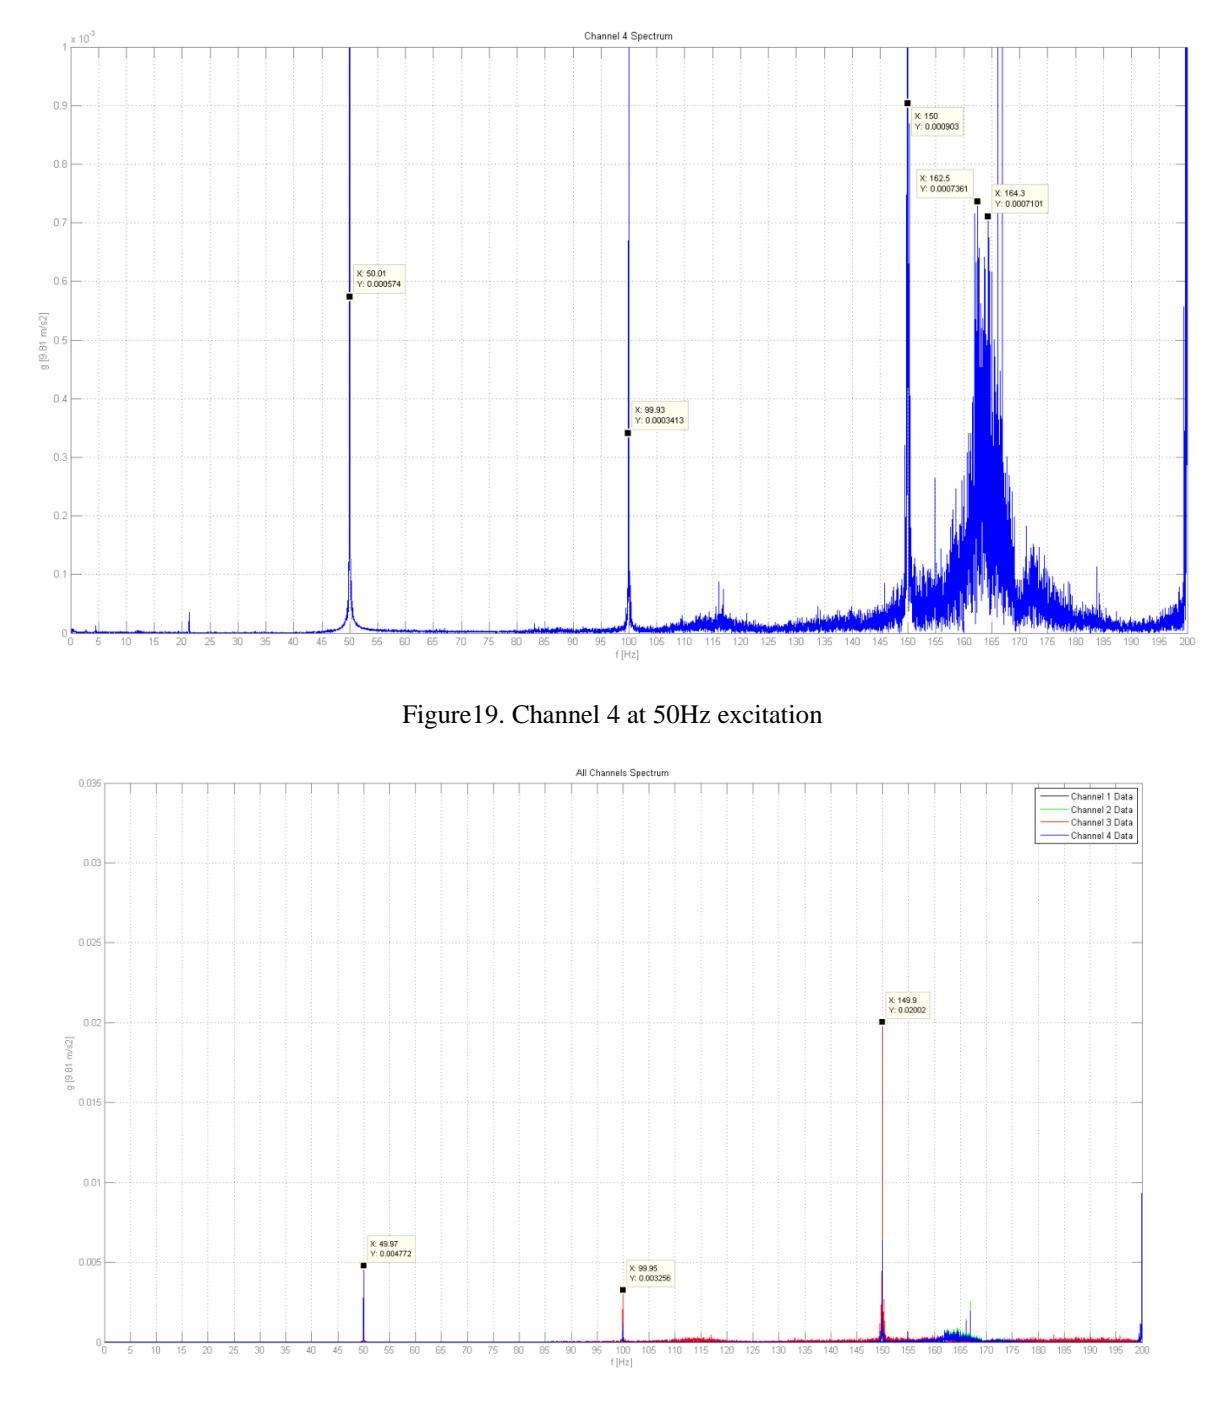
Next figures, Figure 19 and Figure 20, shows one very clear measurement example, this is at 50Hz of driving frequency and without eccentric mass:

Figure 20. All channels 50Hz excitation

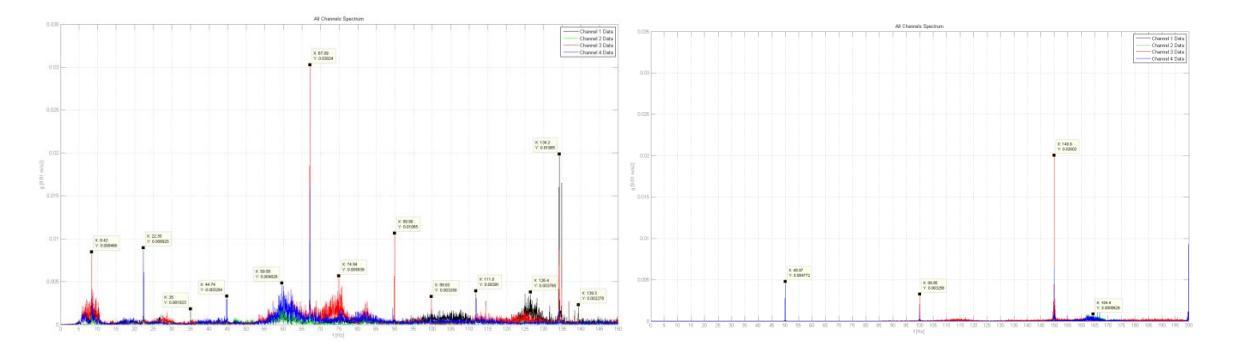
- The first resonance modes has been moved from 59,92 Hz & 74,25Hz to 164,5 Hz.
- With this rigidity increase it is expected the slab deformation strongly decrease and avoiding dangerous motor-pump deformations and continuous misalignment.
- Next Figure 21 shows as for a similar level of harmonic excitation the background vibration is much lower now:

Figure 21: a. P11 Working measurement (45Hz). b. Prototype measurement (50Hz)

- The level of excitation of the resonances is a factor 7 lower than the current slab: from $5 \cdot 10^{-3}$ g to $0,7 \cdot 10^{-3}$ g. With the same excitation amplitude.
 - \circ It was needed to excite with the eccentric mass at 60Hz to reach a similar values than current slab: $3 \cdot 10^{-3}$ g.
- It is proposed to substitute all benches with similar problems:
 - o Design always individual benches
 - As thick as possible
